# High Mountain Hearth Solutions, Inc.

## Confidential Inspection Report

### Three Seasons Condominiums

N.F.P.A. Level II Chimney Inspection

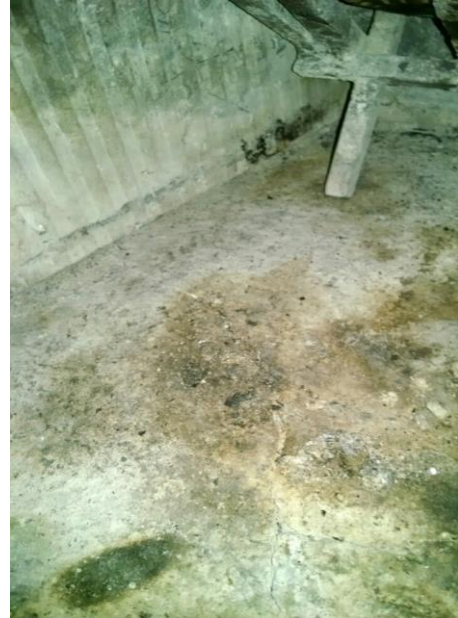
## Firebox Floor

The firebox refractory floor is showing cracks from long term use. These cracks could allow heat and/or sparks down through the refractory. The purpose of the refractory floor is to help insulate the combustible building materials beneath the fireplace. Long term exposure to excessive heat can lower the ignition temperature of the combustible building materials beneath the fireplace, and what may not have been a safety issue in the past could possibly become a fire hazard. Because of this issue, combined with the other issues found in this inspection, it is recommended that, for the protection of life and property, this fireplace and chimney system not be used to burn any type of fire.

A.14.3 (Chimney inspection required to ensure)....(4) General condition of appliance

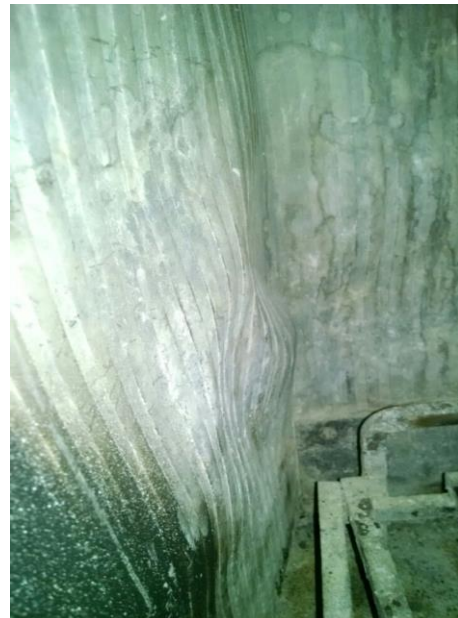
## Firebox Baffles

The firebox baffles on the sides and back of the firebox are warping from long term use. The purpose of the baffles is to help provide an insulating airspace between the firebox and the outside of the fireplace, which is next to the combustible framing of the structure. As the baffles continue to warp, the airspace becomes smaller and misshaped, likely reducing the insulating value the airspace behind the baffles provide. Long term exposure to excessive heat can lower the ignition temperature of the combustible building materials around the fireplace, and what may not have been a safety issue in the past could possibly become a fire hazard. Because of this issue, combined with the other issues found in this inspection, it is recommended that, for the protection of life and property, this fireplace and chimney system not be used to burn any type of fire.

A.14.3 (Chimney inspection required to ensure)....(4) General condition of appliance

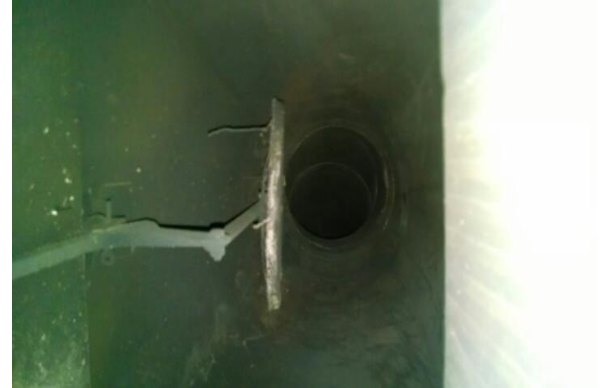
## Fireplace Damper

While the damper in this fireplace appears to function as well as can be expected for a fireplace of this age, it has a tendency to 'stick' and take more force to open and/or close than someone unfamiliar with its operation might think. This could possibly lead to a fire being lit without it being confirmed that the damper is in the full open position. Because of this issue, combined with the other issues found in this inspection, it is recommended that for the protection of life and property, this fireplace and chimney system not be used to burn any type of fire.

A.14.3 (Chimney inspection required to ensure)....(27) Operation and closure of damper assembly

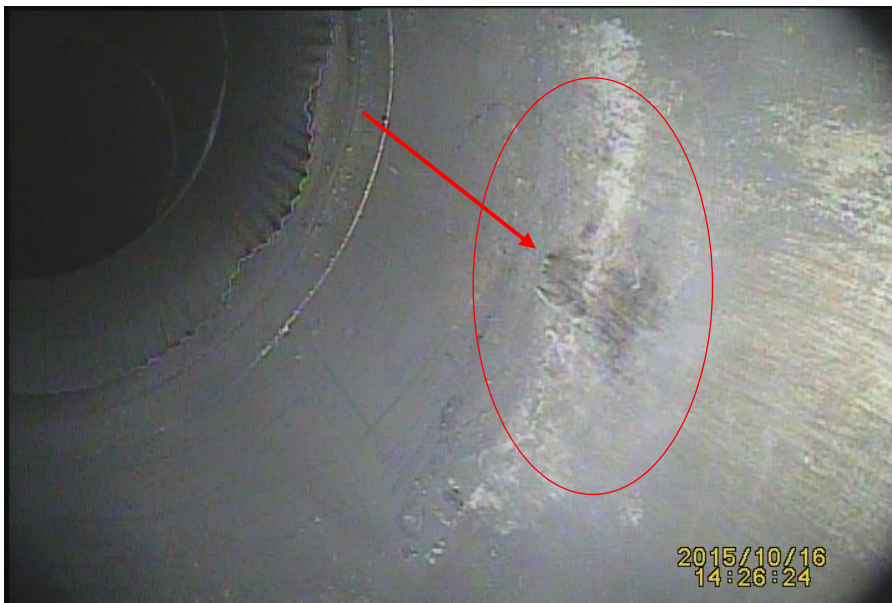
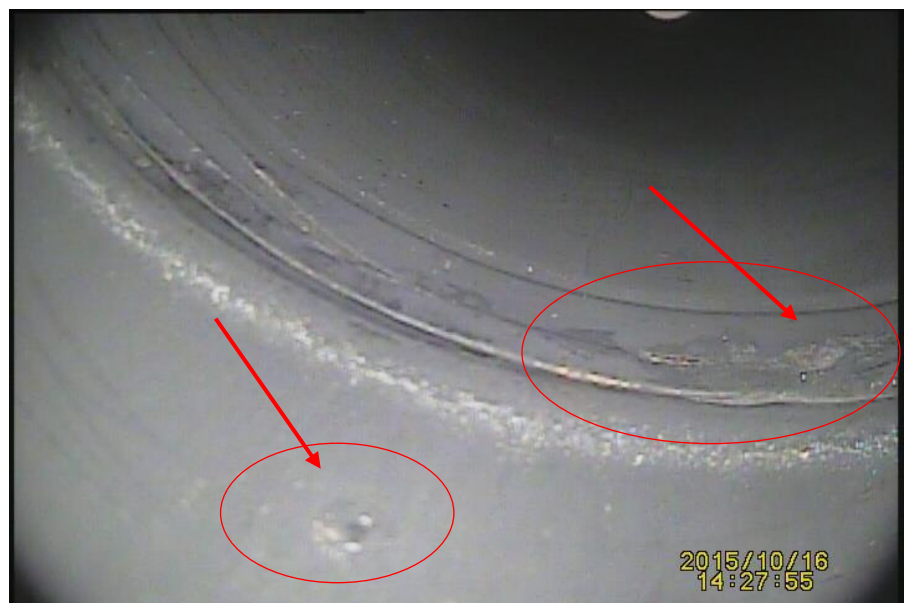
Over time and use, the metals inside the chimney can break down due to the extreme temperatures and the harsh gasses produced during combustion. As seen in the photos below, the video scan of the inside of this chimney shows signs of deterioration. This is an area of serious concern, for the protection of life and property, this fireplace and chimney system should not be used for any type of fire.

A.14.3 (Chimney inspection required to ensure)....(5) Chimney or vent and its connector for general suitability....

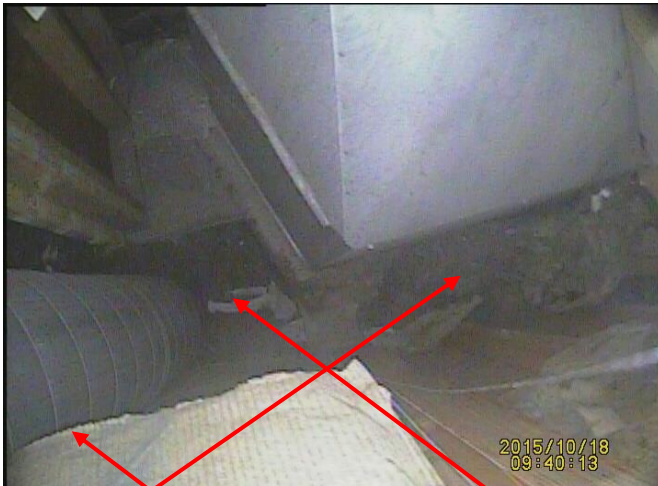
Each time a chimney passes through a floor or ceiling a firestop is required to prevent or slow the spread of flames and smoke in the unfortunate event of a fire. Units on the first floor should have 3 firestops, one at the first floor ceiling, second floor ceiling, and third floor ceiling. Second floor units should have two firestops, and third floor units should have one. Throughout the entire complex we found virtually no adequate firestops. The photos below are representative of the conditions found. This is an area of real concern, for the protection of life and property, this fireplace and chimney system should not be used for any type of fire.

7.1.6.2 All spaces between chimneys and the floors and ceilings through which the chimneys pass shall remain fully open but shall be firestopped with noncombustible material.

Insulation touching chimney & fireplace, a 2" airspace is required

No firestop provided where chimney passes through floor/ceiling

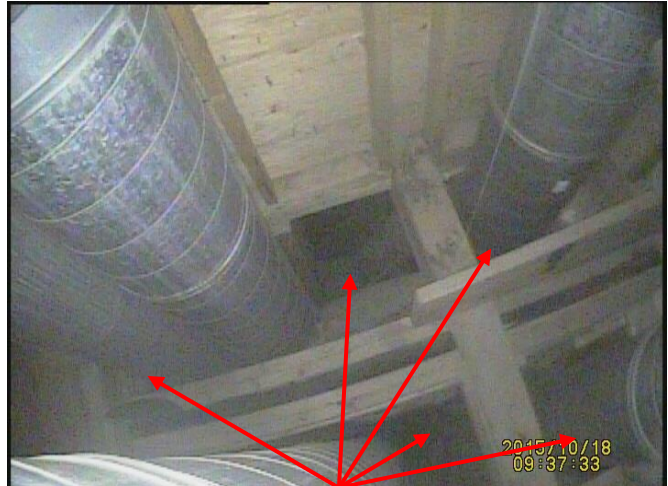
Each chimney must have a firestop where it passes through a floor/ceiling. No firestops have been provided

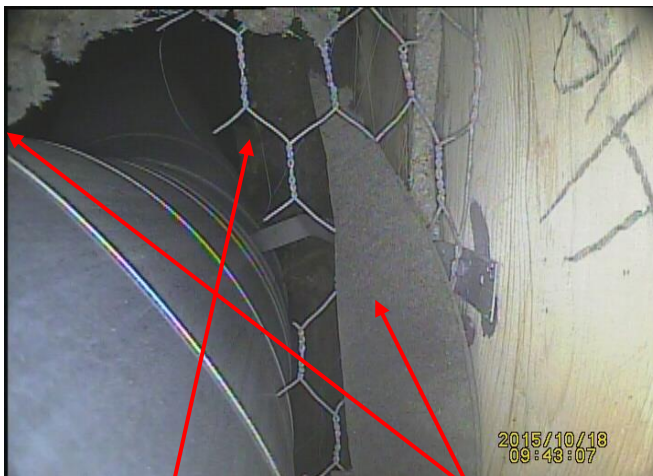
No firestop provided where chimney passes through floor/ceiling

Debris touching chimney, a 2" airspace must be maintained

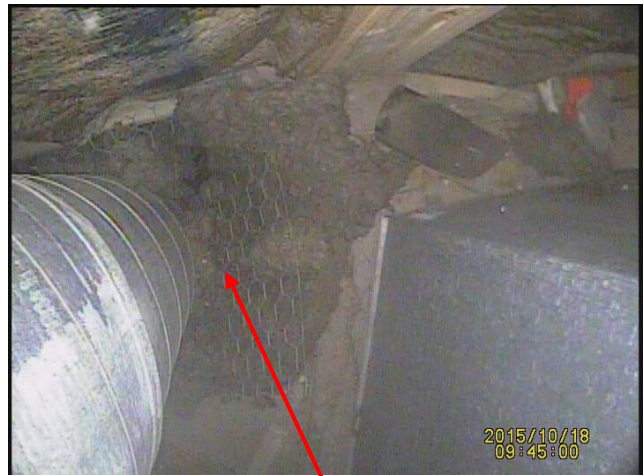
It appears that insulation has been placed on chicken wire in place of an adequate firestop. This is not approved and is a fire hazard
