Confidential Inspection Report

Three Seasons Condominiums

701 Gothic Rd
Mt Crested Butte, CO 81225

N.F.P.A. Level II Chimney Inspection

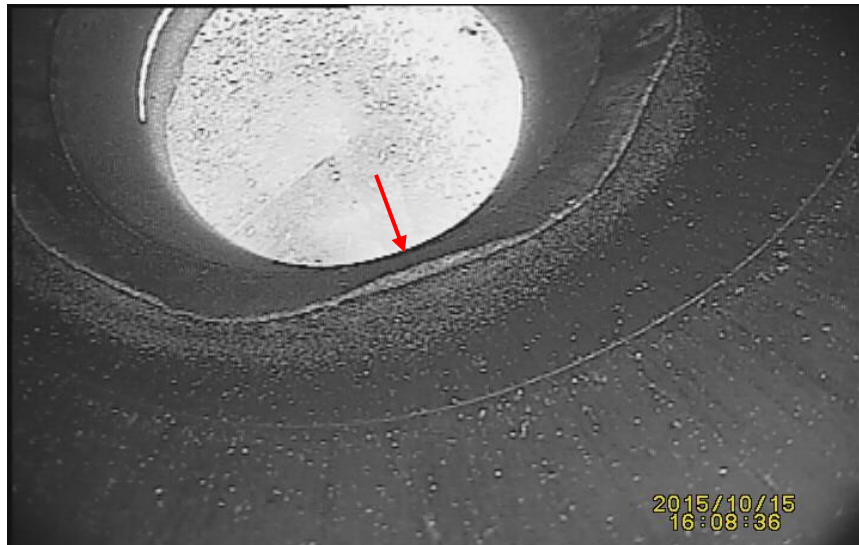
Interior Chimney Scan

Over time and use, the metals inside the chimney can break down due to the extreme temperatures and the harsh gasses produced during combustion. As seen in the photos below, the video scan of the inside of this chimney shows signs of deteriorated joints. This is an area of serious concern, for the protection of life and property, this fireplace and chimney system should not be used for any type of fire.

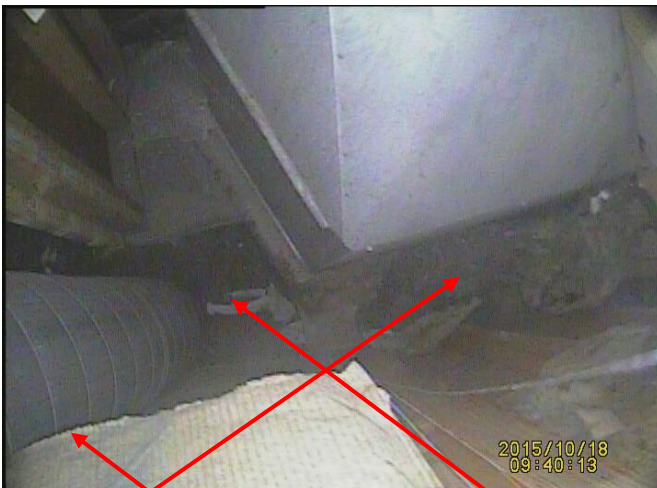
Each time a chimney passes through a floor or ceiling a firestop is required to prevent or slow the spread of flames and smoke in the unfortunate event of a fire. Units on the first floor should have 3 firestops, one at the first floor ceiling, second floor ceiling, and third floor ceiling. Second floor units should have two firestops, and third floor units should have one. Throughout the entire complex we found virtually no adequate firestops. The photos below are representative of the conditions found. This is an area of real concern, for the protection of life and property, this fireplace and chimney system should not be used for any type of fire.

Insulation touching chimney & fireplace, a 2" airspace is required

No firestop provided where chimney passes through floor/ceiling

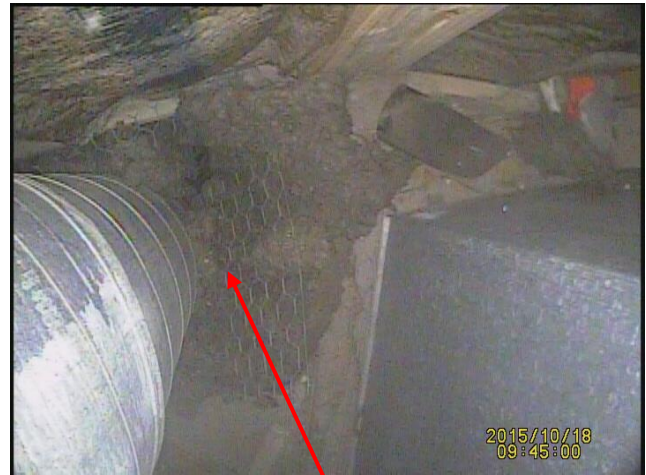
It appears that insulation has been placed on chicken wire in place of an adequate firestop. This is not approved and is a fire hazard
