# High Mountain Hearth Solutions, Inc.

## Confidential Inspection Report

### Three Seasons Condominiums

N.F.P.A. Level II Chimney Inspection

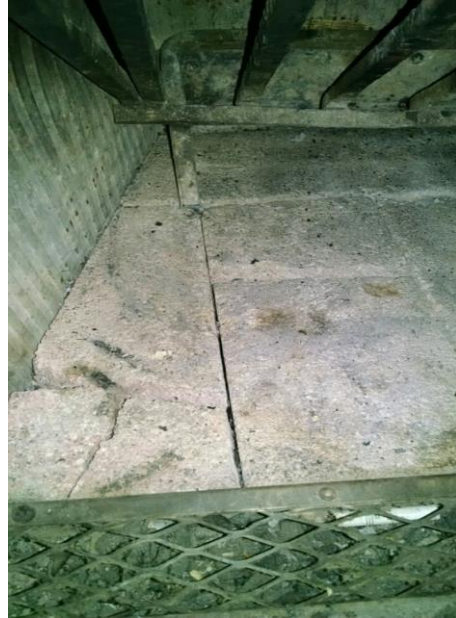
## Firebox Floor

The firebox refractory floor is showing cracks from long term use. The purpose of the refractory floor is to help insulate the combustible building materials beneath the fireplace. Firebricks are installed on top of the refractory floor, which is acceptable except there are large cracks between the bricks which could allow heat and/or sparks down in between the bricks. Long term exposure to excessive heat can lower the ignition temperature of the combustible building materials beneath the fireplace, and what may not have been a safety issue in the past could possibly become a fire hazard. Because of this issue, combined with the other issues found in this inspection, it is recommended that, for the protection of life and property, this fireplace and chimney system not be used to burn any type of fire.

A.14.3 (Chimney inspection required to ensure)....(4) General condition of appliance

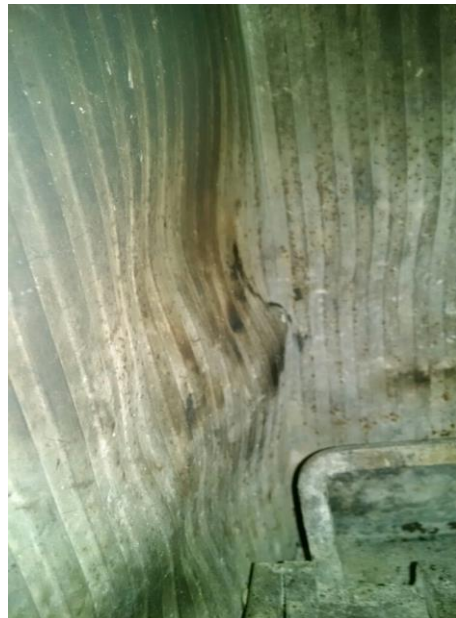
## Firebox Baffles

The firebox baffles on the sides and back of the firebox are warping from long term use. The purpose of the baffles is to help provide an insulating airspace between the firebox and the outside of the fireplace, which is next to the combustible framing of the structure. As the baffles continue to warp, the airspace becomes smaller and misshaped, likely reducing the insulating value the airspace behind the baffles provide. Long term exposure to excessive heat can lower the ignition temperature of the combustible building materials around the fireplace, and what may not have been a safety issue in the past could possibly become a fire hazard. Because of this issue, combined with the other issues found in this inspection, it is recommended that, for the protection of life and property, this fireplace and chimney system not be used to burn any type of fire.

A.14.3 (Chimney inspection required to ensure)....(4) General condition of appliance

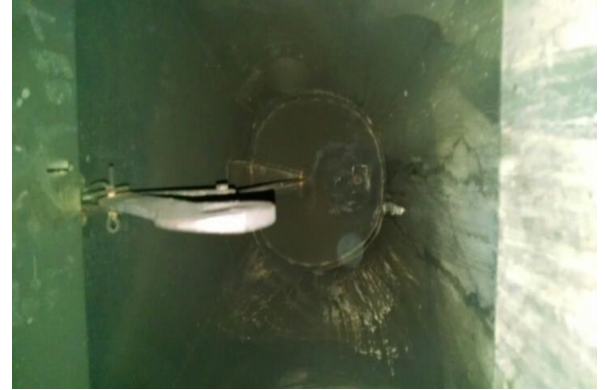
## Fireplace Damper

While the damper in this fireplace appears to function as well as can be expected for a fireplace of this age, it has a tendency to 'stick' and take more force to open and/or close than someone unfamiliar with its operation might think. This could possibly lead to a fire being lit without it being confirmed that the damper is in the full open position. Because of this issue, combined with the other issues found in this inspection, it is recommended that for the protection of life and property, this fireplace and chimney system not be used to burn any type of fire.

A.14.3 (Chimney inspection required to ensure)....(27) Operation and closure of damper assembly

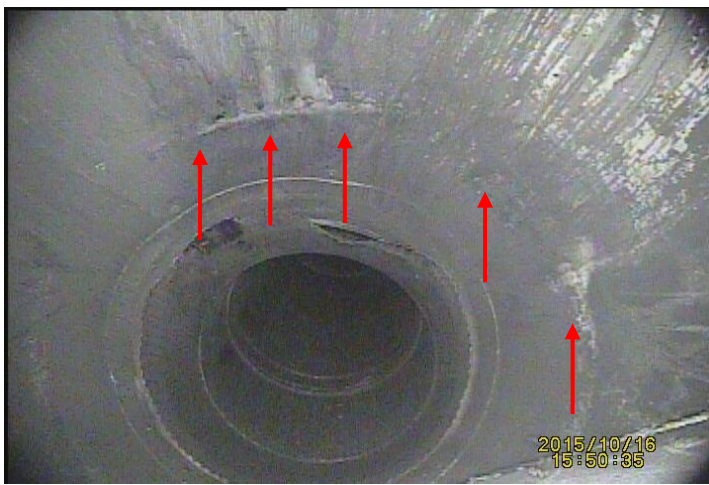
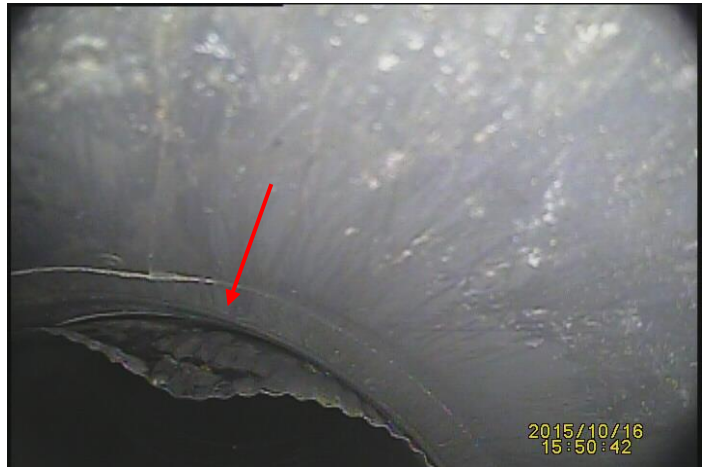
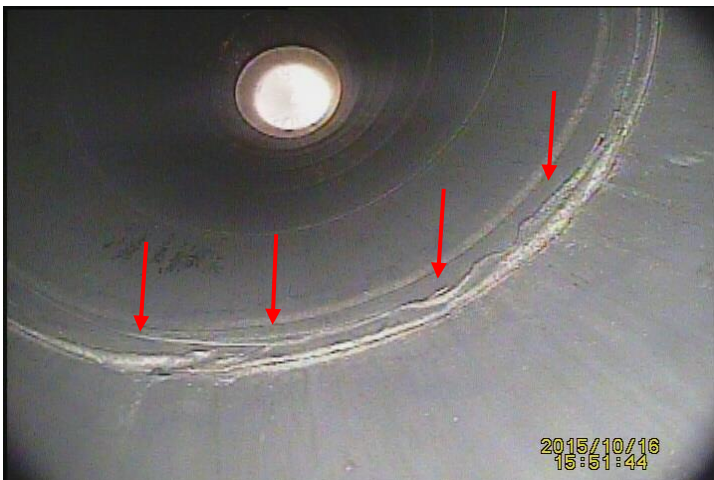
## Interior Chimney Scan

Over time and use, the metals inside the chimney can break down due to the extreme temperatures and the harsh gasses produced during combustion. As seen in the photos below, the video scan of the inside of this chimney shows signs of damaged joints and deterioration. This is an area of serious concern, for the protection of life and property, this fireplace and chimney system should not be used for any type of fire.

A.14.3 (Chimney inspection required to ensure)....(5) Chimney or vent and its connector for general suitability....

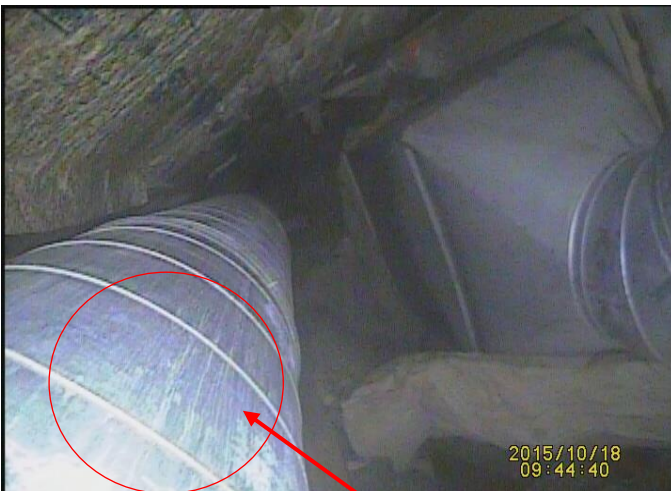
Many of the chimneys in this complex show evidence of moisture on the outside of the outer wall of the chimney. Judging by how the moisture entered and exited the different layers at the joints of the chimneys, it is evident that the moisture has been both on the inside and outside of the outer wall of the chimney. Over time, moisture can break down the integrity of the walls and joints of the chimney, weakening the system and making it unsafe to use. The photos below are representative of the conditions found.

Lines of moisture running in and out of the seams of the outer wall of the chimney

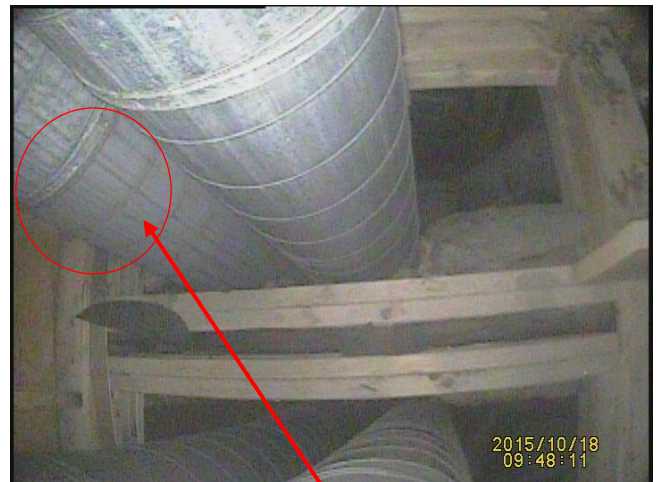
Lines of moisture running in and out of the seams of the outer wall of the chimney

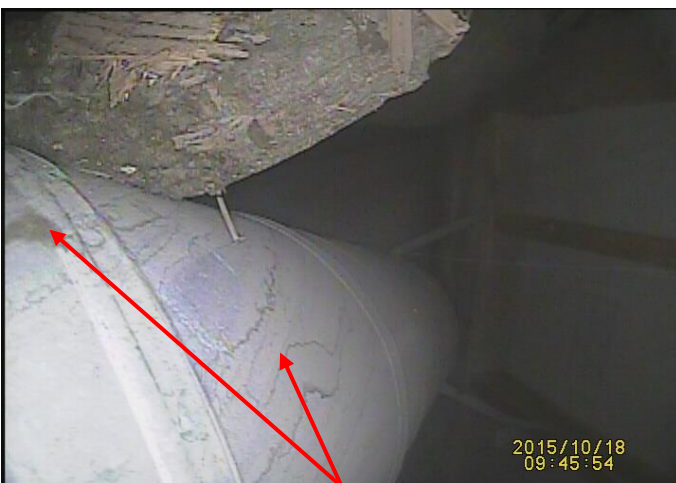
Signs of moisture presents on the outer wall of the chimney

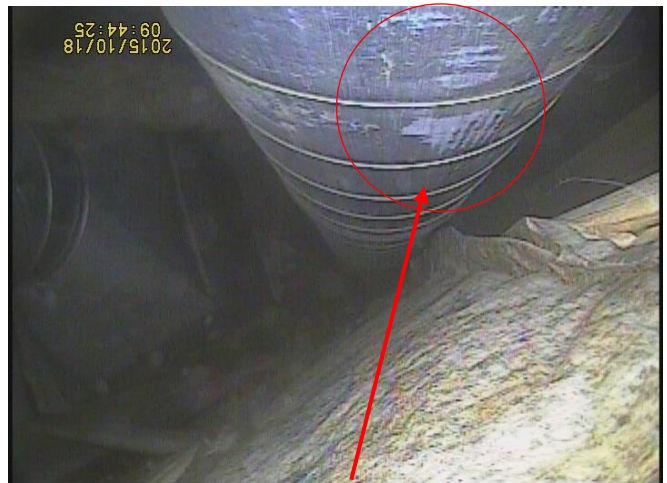
Signs of moisture damage on the outer wall of the chimney

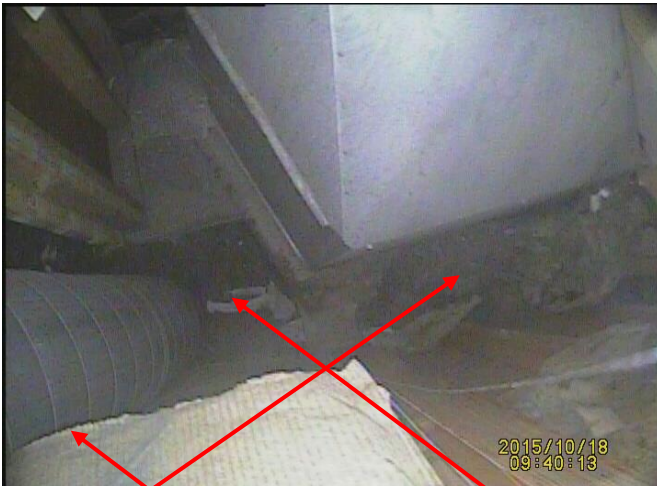
7.1.6.2 All spaces between chimneys and the floors and ceilings through which the chimneys pass shall remain fully open but shall be firestopped with noncombustible material.

Insulation touching chimney & fireplace, a 2" airspace is required

No firestop provided where chimney passes through floor/ceiling

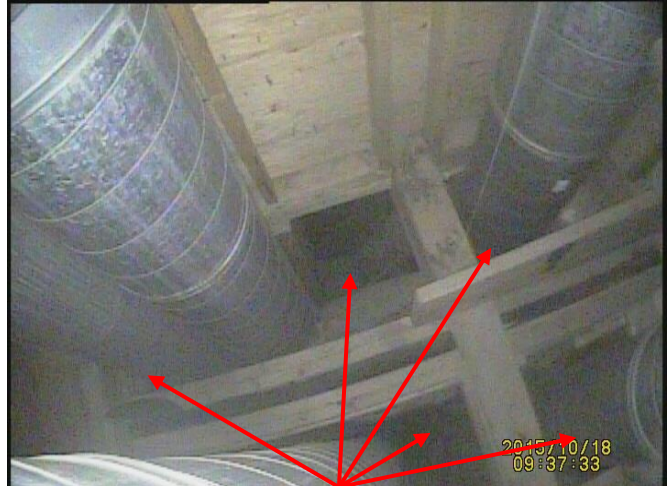
Each chimney must have a firestop where it passes through a floor/ceiling. No firestops have been provided

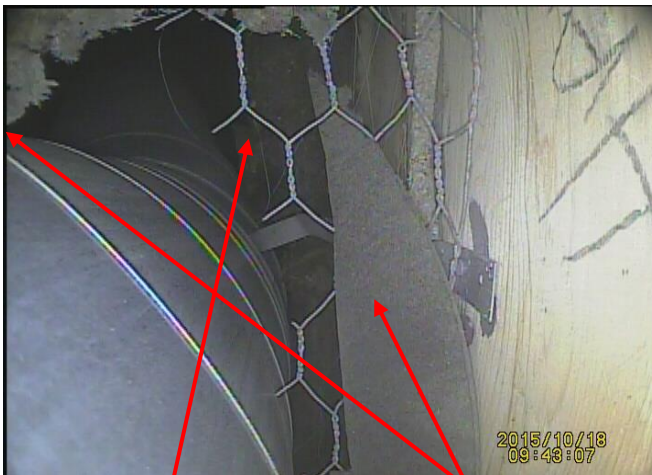
No firestop provided where chimney passes through floor/ceiling

Debris touching chimney, a 2" airspace must be maintained

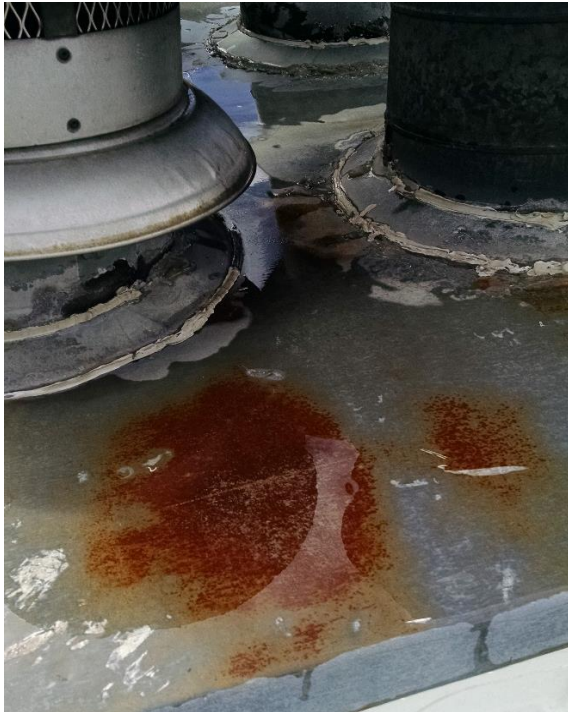
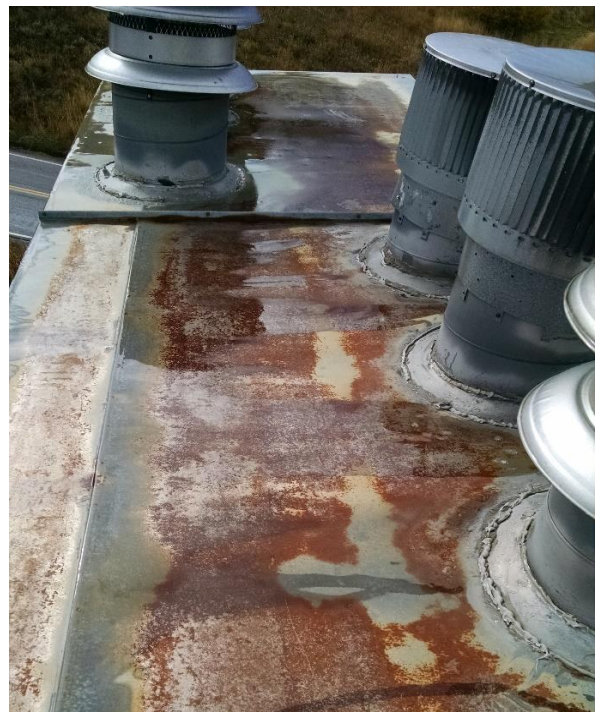
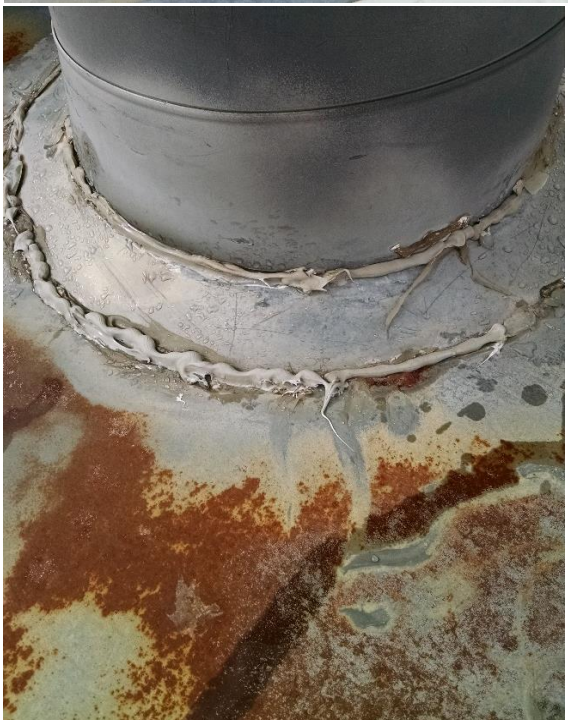
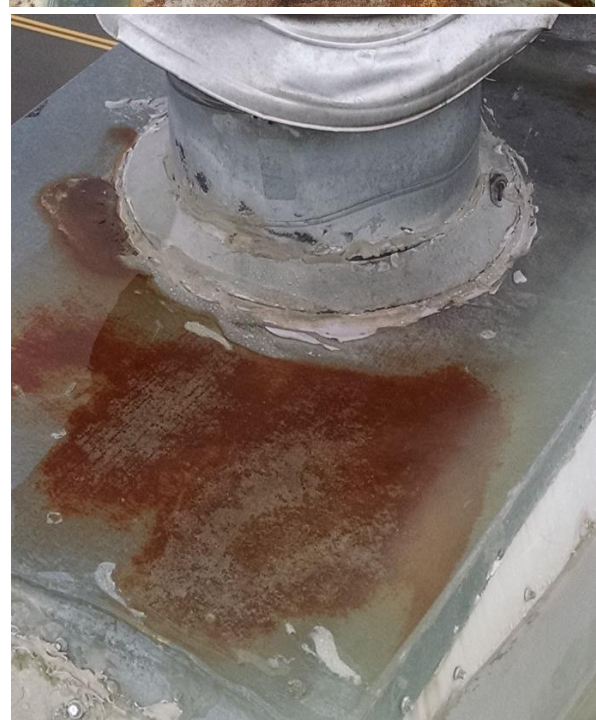
## Chase Top Termination

The photos below show that the metal composing the chase covers on this complex is rusting and deteriorating. At the time of this inspection the covers have not rusted through, but it is recommended that these chase covers be replaced in the near future to prevent property damage. The photos below are representative of the conditions found.
