# High Mountain Hearth Solutions, Inc.

## Confidential Inspection Report

### Three Seasons Condominiums

N.F.P.A. Level II Chimney Inspection

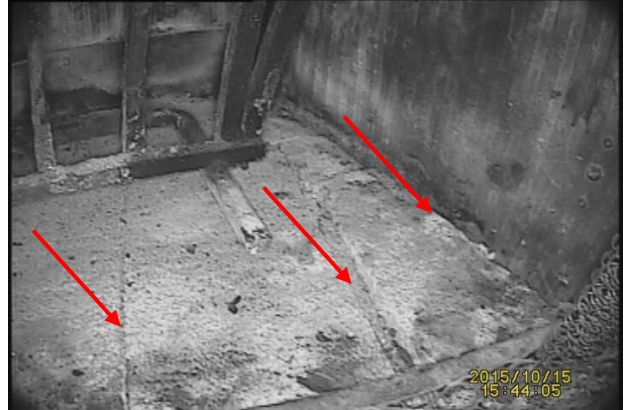
The firebox refractory floor is showing cracks from long term use. The purpose of the refractory floor is to help insulate the combustible building materials beneath the fireplace. Firebricks are installed on top of the refractory floor, which is acceptable except there are large cracks between the bricks which could allow heat and/or sparks down in between the bricks. Long term exposure to excessive heat can lower the ignition temperature of the combustible building materials beneath the fireplace, and what may not have been a safety issue in the past could possibly become a fire hazard. Because of this issue, combined with the other issues found in this inspection, it is recommended that, for the protection of life and property, this fireplace and chimney system not be used to burn any type of fire.

A.14.3 (Chimney inspection required to ensure)....(4) General condition of appliance

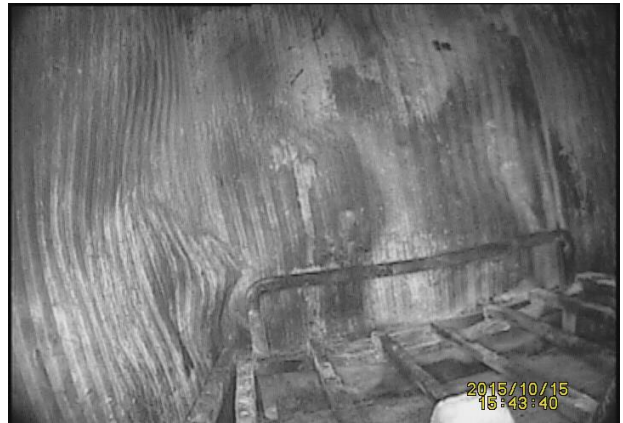
The firebox baffles on the sides and back of the firebox are warping from long term use. The purpose of the baffles is to help provide an insulating airspace between the firebox and the outside of the fireplace, which is next to the combustible framing of the structure. As the baffles continue to warp, the airspace becomes smaller and misshaped, likely reducing the insulating value the airspace behind the baffles provide. Long term exposure to excessive heat can lower the ignition temperature of the combustible building materials around the fireplace, and what may not have been a safety issue in the past could possibly become a fire hazard. Because of this issue, combined with the other issues found in this inspection, it is recommended that, for the protection of life and property, this fireplace and chimney system not be used to burn any type of fire.

A.14.3 (Chimney inspection required to ensure)....(4) General condition of appliance

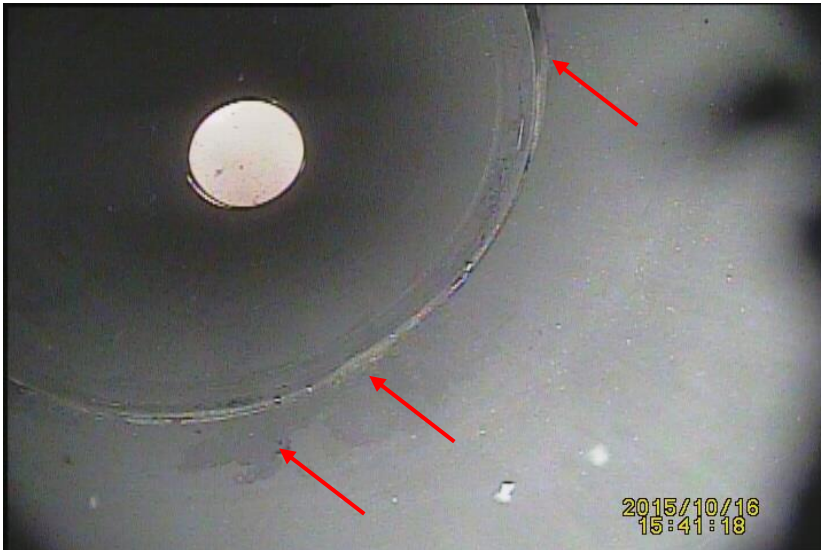
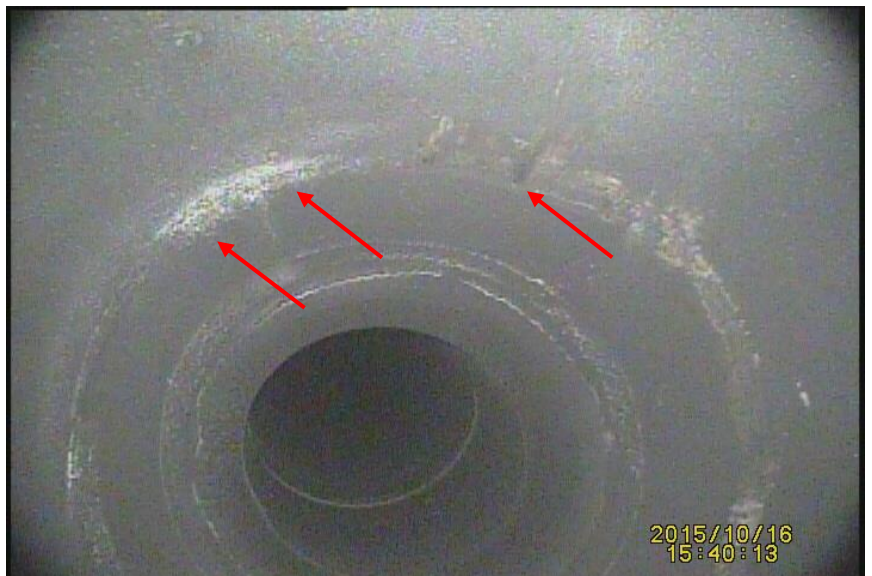
Over time and use, the metals inside the chimney can break down due to the extreme temperatures and the harsh gasses produced during combustion. As seen in the photos below, the video scan of the inside of this chimney shows signs of deteriorated joints. This is an area of serious concern, for the protection of life and property, this fireplace and chimney system should not be used for any type of fire.

A.14.3 (Chimney inspection required to ensure).....(5) Chimney or vent and its connector for general suitability....

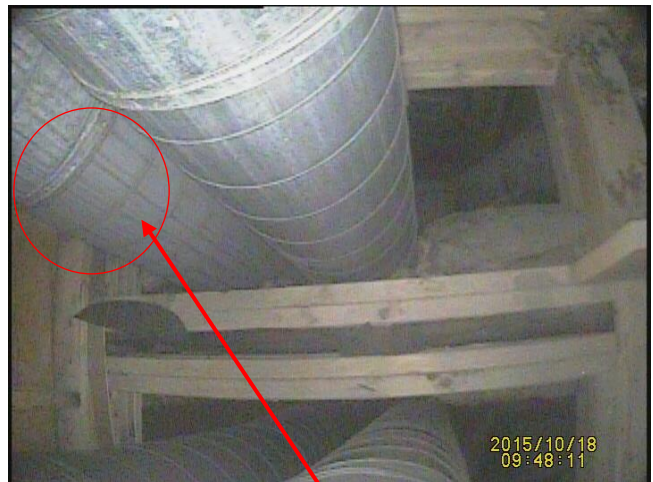
Lines of moisture running in and out of the seams of the outer wall of the chimney

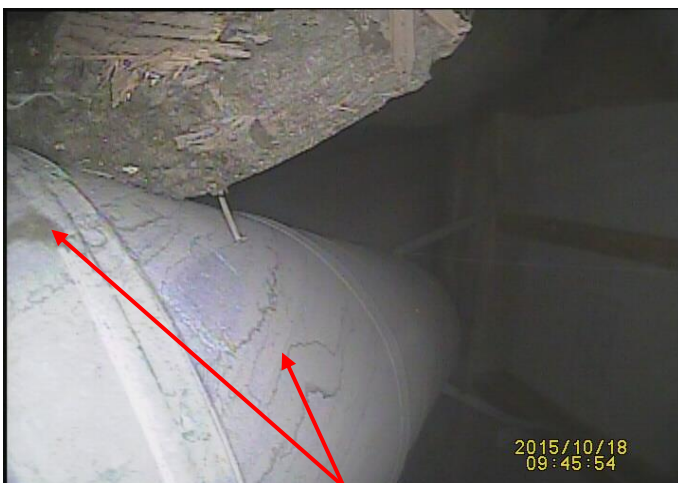
Signs of moisture presents on the outer wall of the chimney

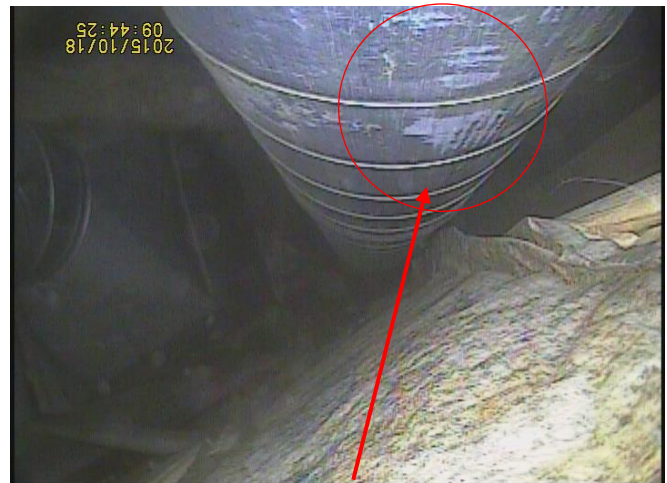
Signs of moisture damage on the outer wall of the chimney

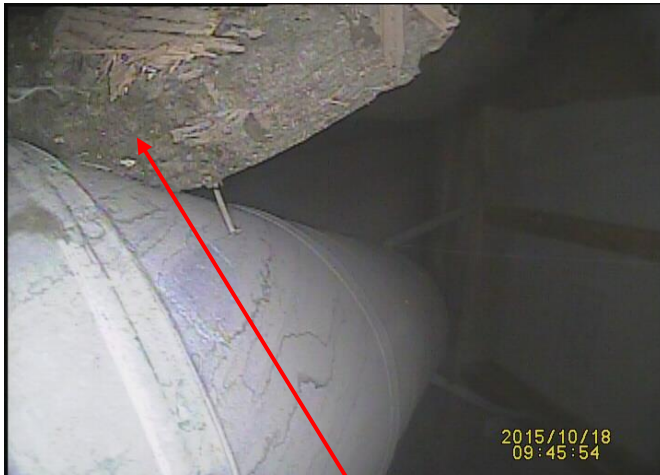
This listed and tested manufactured chimney pipe requires 2" clearance to combustible materials. Inside virtually every chase in the complex, virtually every chimney was in contact with, or had inadequate clearance to, combustible materials. The photos below are representative of the conditions found. This is an area of serious concern, for the protection of life and property, this fireplace and chimney system should not be used for any type of fire.

Combustible building material in direct contact with the chimney. This is a serious fire hazard

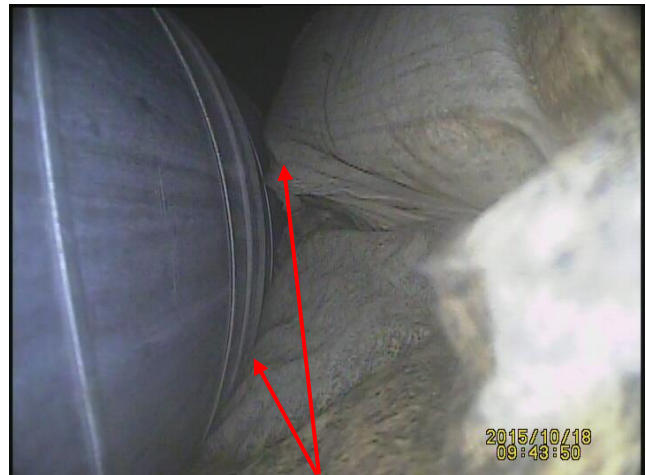
Combustible insulation in direct contact with the chimney. This is a serious fire hazard

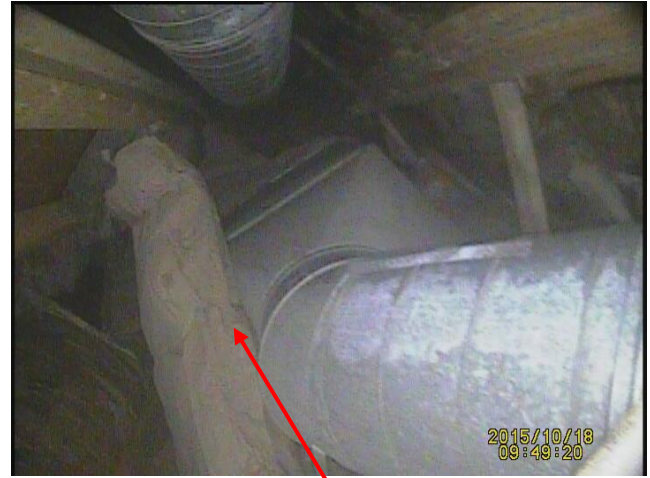
Insulation has fallen on top of a fireplace. This is a serious fire hazard

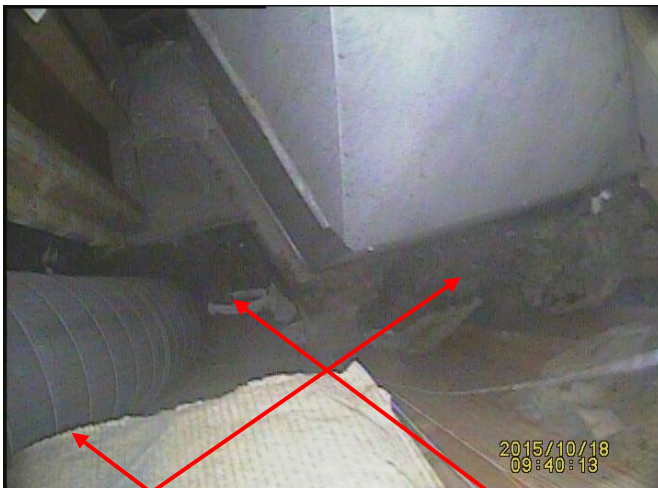
Insulation touching chimney & fireplace, a 2" airspace is required

No firestop provided where chimney passes through floor/ceiling

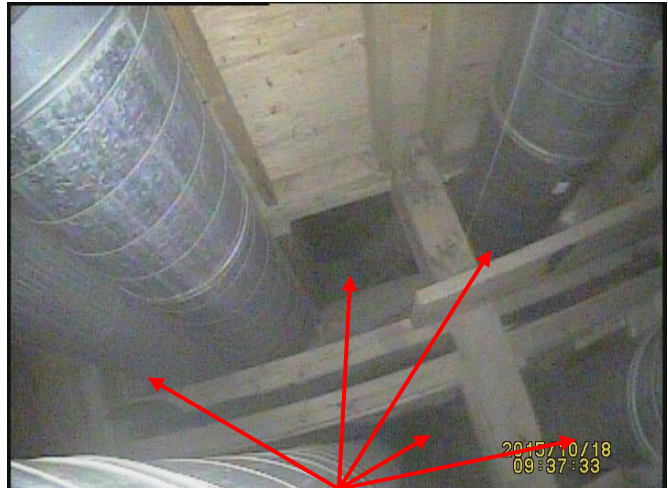
Each chimney must have a firestop where it passes through a floor/ceiling. No firestops have been provided

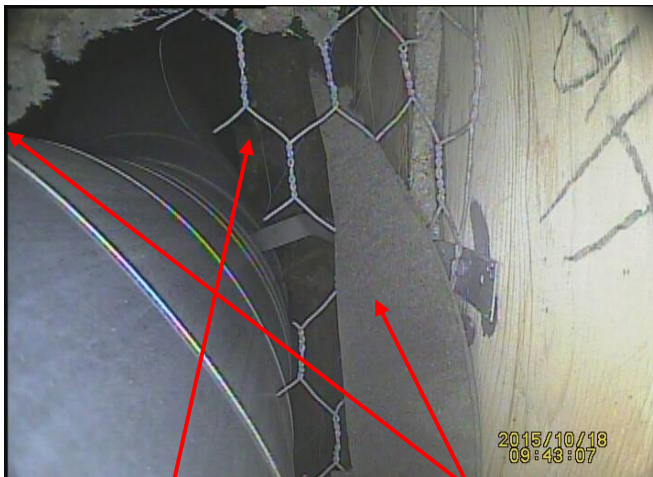
No firestop provided where chimney passes through floor/ceiling

Debris touching chimney, a 2" airspace must be maintained

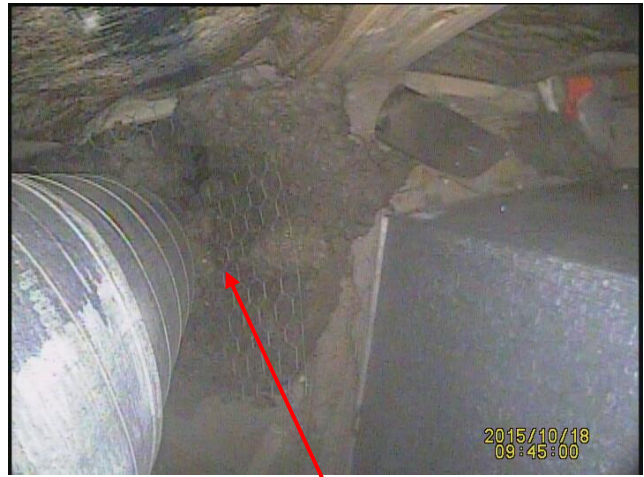
It appears that insulation has been placed on chicken wire in place of an adequate firestop. This is not approved and is a fire hazard

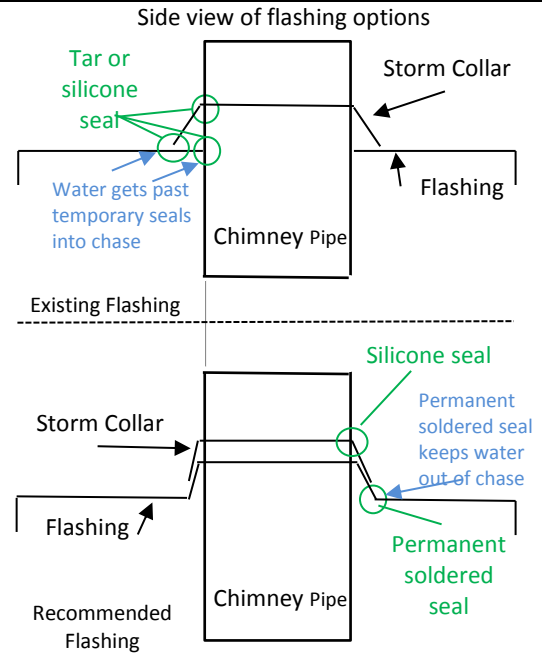
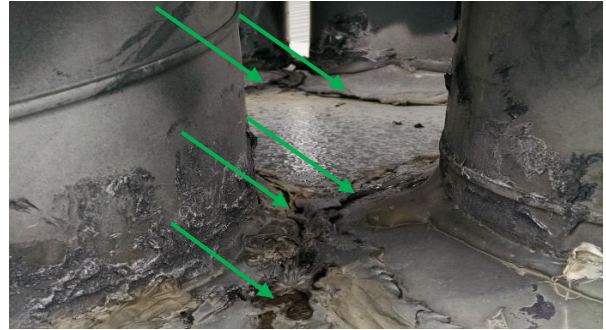
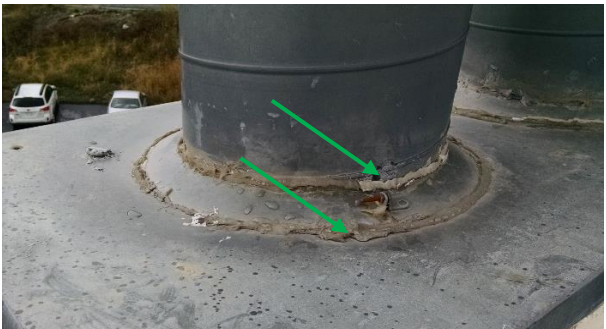
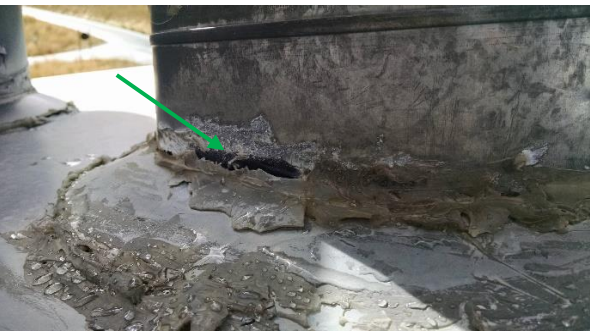
The storm collar seal on the chimneys in these chases is no longer keeping out all of the moisture. This type of flashing construction relies on temporary seals like tar or silicone to keep moisture from entering the structure, and these components break down over time, as is the case with these chase covers. If constructed differently, a soldered joint is the primary barrier which keeps the moisture out of the chase. A short term fix would be to reseal the existing storm collars, but it is recommended that in the near future the chase covers be replaced with covers that have a soldered collar in place as the primary defense against moisture. The photos below are representative of the conditions found.
