# High Mountain Hearth Solutions, Inc.

## Confidential Inspection Report

### Three Seasons Condominiums

N.F.P.A. Level II Chimney Inspection

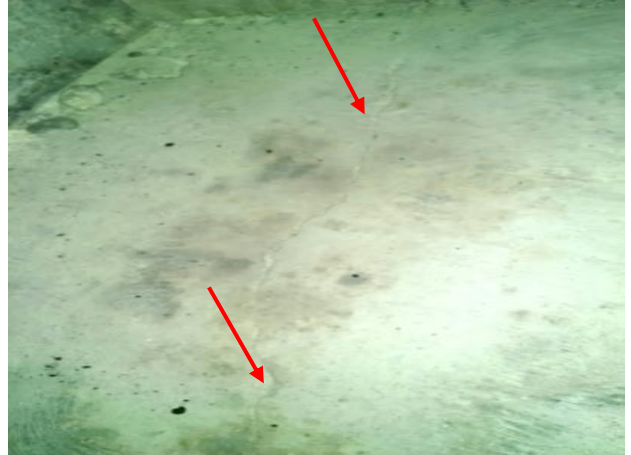
The firebox refractory floor is showing cracks from long term use. The purpose of the refractory floor is to help insulate the combustible building materials beneath the fireplace. A tight row of firebricks installed on top of the refractory floor would be acceptable. Long term exposure to excessive heat can lower the ignition temperature of the combustible building materials beneath the fireplace, and what may not have been a safety issue in the past could possibly become a fire hazard. Because of this issue, combined with the other issues found in this inspection, it is recommended that, for the protection of life and property, this fireplace and chimney system not be used to burn any type of fire.

A.14.3 (Chimney inspection required to ensure).....(4) General condition of appliance

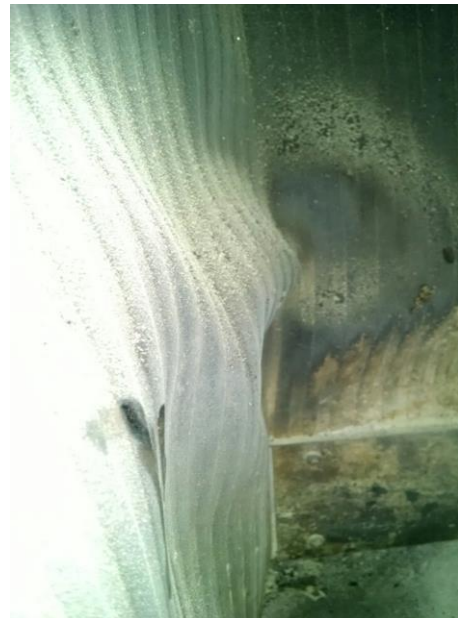
The firebox baffles on the sides and back of the firebox are warping from long term use. The purpose of the baffles is to help provide an insulating airspace between the firebox and the outside of the fireplace, which is next to the combustible framing of the structure. As the baffles continue to warp, the airspace becomes smaller and misshaped, likely reducing the insulating value the airspace behind the baffles provide. Long term exposure to excessive heat can lower the ignition temperature of the combustible building materials around the fireplace, and what may not have been a safety issue in the past could possibly become a fire hazard. Because of this issue, combined with the other issues found in this inspection, it is recommended that, for the protection of life and property, this fireplace and chimney system not be used to burn any type of fire.

A.14.3 (Chimney inspection required to ensure).....(4) General condition of appliance

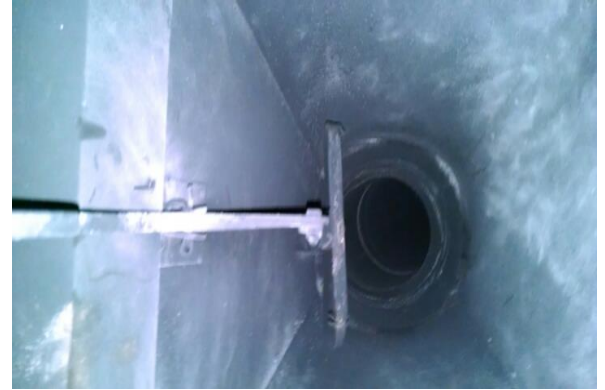
While the damper in this fireplace appears to function as well as can be expected for a fireplace of this age, it has a tendency to 'stick' and take more force to open and/or close than someone unfamiliar with its operation might think. This could possibly lead to a fire being lit without it being confirmed that the damper is in the full open position. Because of this issue, combined with the other issues found in this inspection, it is recommended that for the protection of life and property, this fireplace and chimney system not be used to burn any type of fire.

A.14.3 (Chimney inspection required to ensure)....(27) Operation and closure of damper assembly

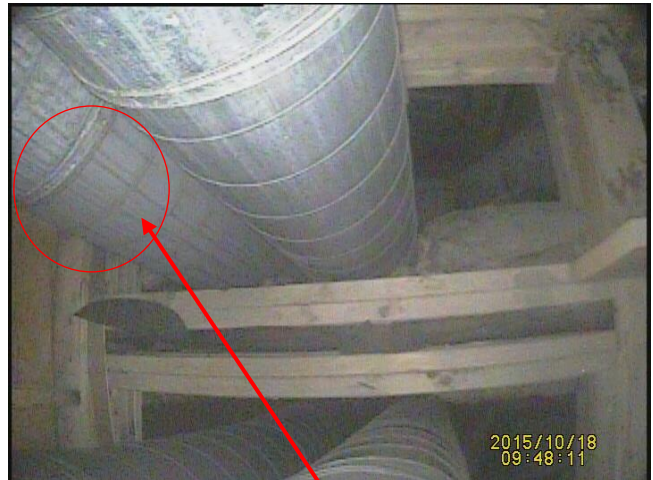
Many of the chimneys in this complex show evidence of moisture on the outside of the outer wall of the chimney. Judging by how the moisture entered and exited the different layers at the joints of the chimneys, it is evident that the moisture has been both on the inside and outside of the outer wall of the chimney. Over time, moisture can break down the integrity of the walls and joints of the chimney, weakening the system and making it unsafe to use. The photos below are representative of the conditions found.

Lines of moisture running in and out of the seams of the outer wall of the chimney

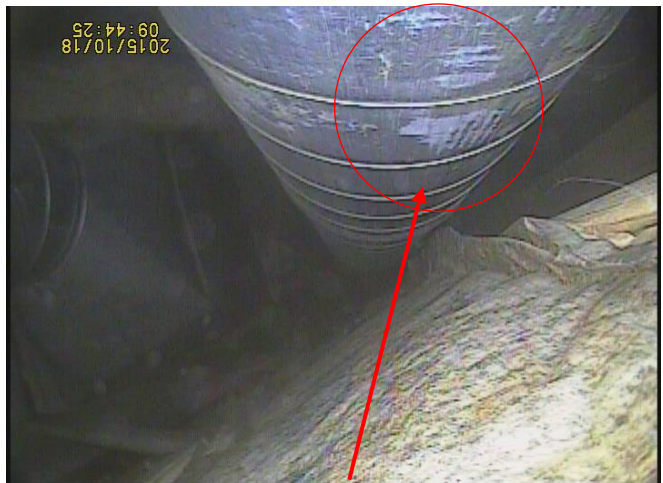
Signs of moisture damage on the outer wall of the chimney

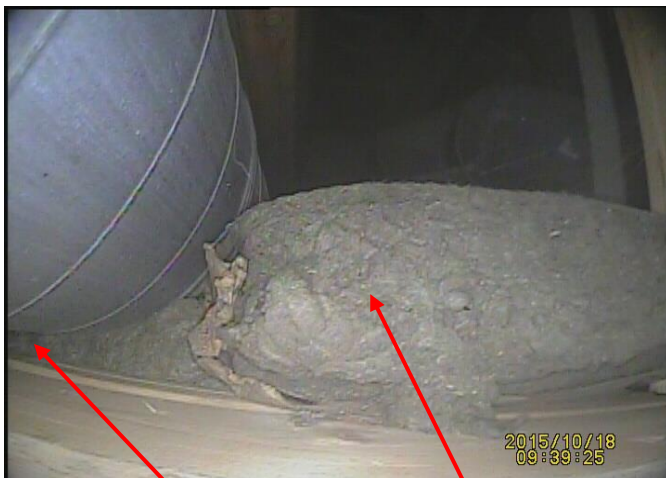
This listed and tested manufactured chimney pipe requires 2" clearance to combustible materials. Inside virtually every chase in the complex, virtually every chimney was in contact with, or had inadequate clearance to, combustible materials. The photos below are representative of the conditions found. This is an area of serious concern, for the protection of life and property, this fireplace and chimney system should not be used for any type of fire.

Inadequate clearance to combustible building materials and insulation, which are in direct contact with the chimney. This is a serious fire hazard
