# High Mountain Hearth Solutions, Inc.

## Confidential Inspection Report

### Three Seasons Condominiums

N.F.P.A. Level II Chimney Inspection

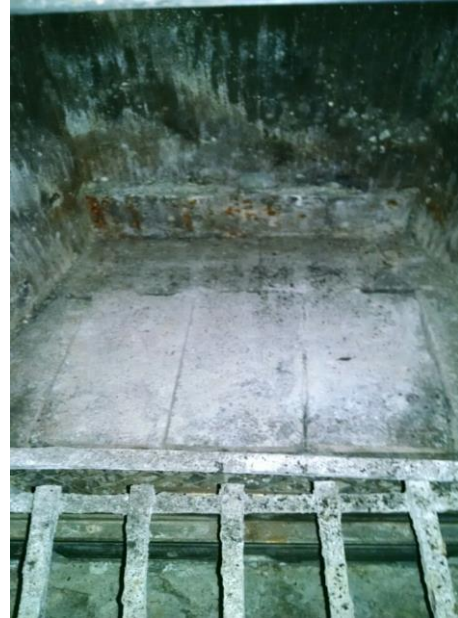
The firebox refractory floor is showing cracks from long term use. The purpose of the refractory floor is to help insulate the combustible building materials beneath the fireplace. Firebricks are installed on top of the refractory floor, which is acceptable except there are large cracks between the bricks which could allow heat and/or sparks down in between the bricks. Long term exposure to excessive heat can lower the ignition temperature of the combustible building materials beneath the fireplace, and what may not have been a safety issue in the past could possibly become a fire hazard. Because of this issue, combined with the other issues found in this inspection, it is recommended that, for the protection of life and property, this fireplace and chimney system not be used to burn any type of fire.

A.14.3 (Chimney inspection required to ensure).....(4) General condition of appliance

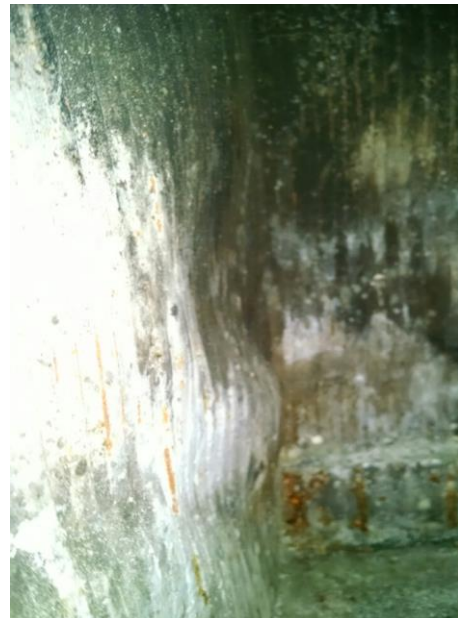
The firebox baffles on the sides and back of the firebox are warping from long term use. The purpose of the baffles is to help provide an insulating airspace between the firebox and the outside of the fireplace, which is next to the combustible framing of the structure. As the baffles continue to warp, the airspace becomes smaller and misshaped, likely reducing the insulating value the airspace behind the baffles provide. Long term exposure to excessive heat can lower the ignition temperature of the combustible building materials around the fireplace, and what may not have been a safety issue in the past could possibly become a fire hazard. Because of this issue, combined with the other issues found in this inspection, it is recommended that, for the protection of life and property, this fireplace and chimney system not be used to burn any type of fire.

A.14.3 (Chimney inspection required to ensure).....(4) General condition of appliance

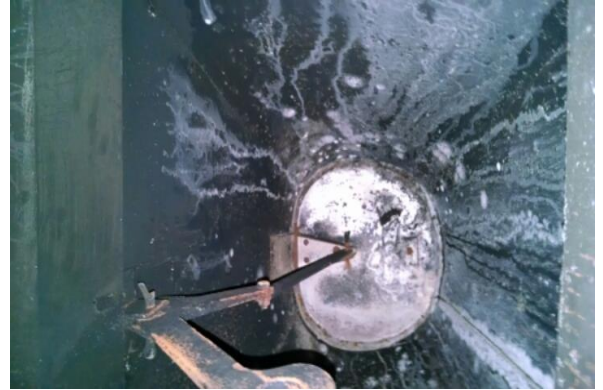
While the damper in this fireplace appears to function as well as can be expected for a fireplace of this age, it has a tendency to 'stick' and take more force to open and/or close than someone unfamiliar with its operation might think. This could possibly lead to a fire being lit without it being confirmed that the damper is in the full open position. Because of this issue, combined with the other issues found in this inspection, it is recommended that for the protection of life and property, this fireplace and chimney system not be used to burn any type of fire.

A.14.3 (Chimney inspection required to ensure).....(27) Operation and closure of damper assembly

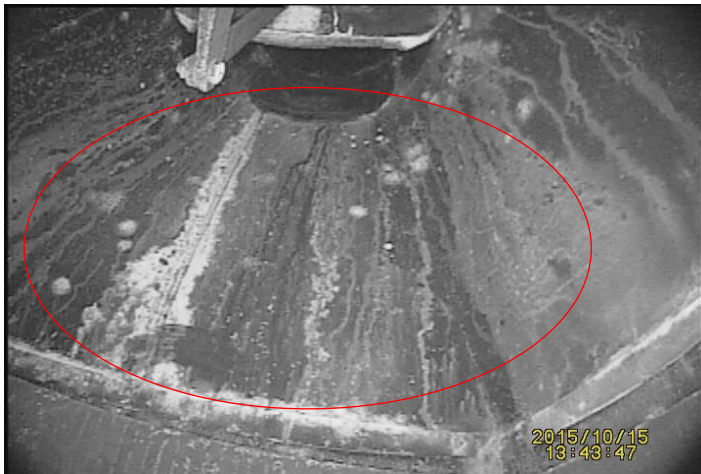
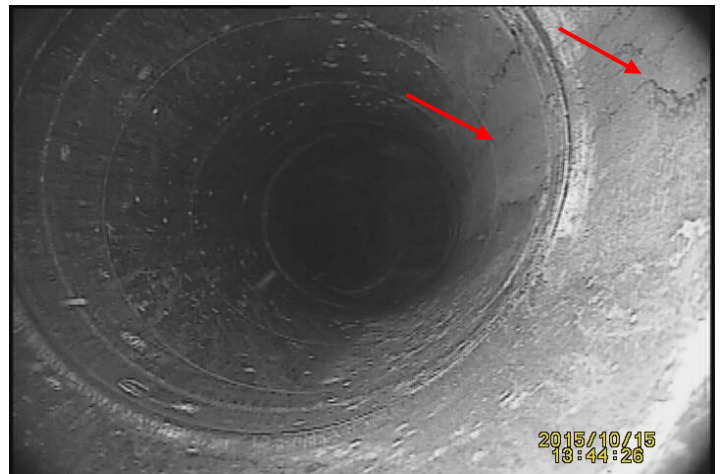
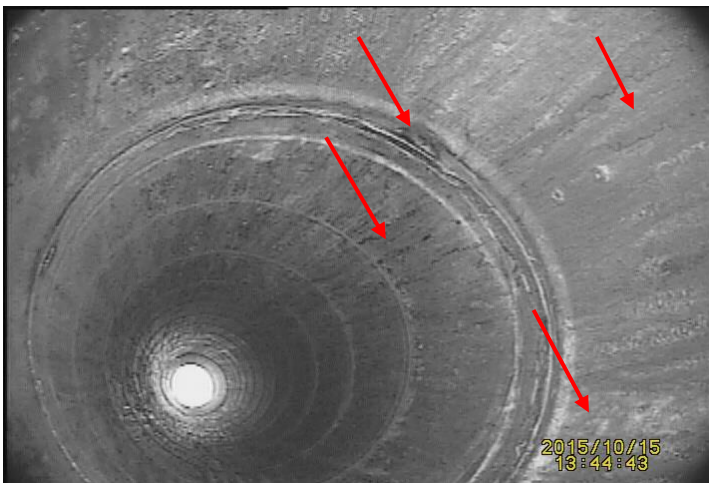
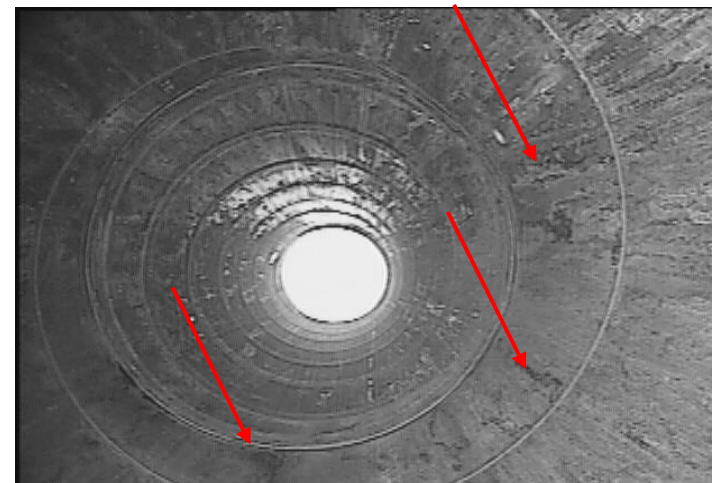
Over time and use, the metals inside the chimney can break down due to the extreme temperatures and the harsh gasses produced during combustion. As seen in the photos below, the video scan of the inside of this chimney shows that the entire inner liner has signs of excessive moisture damage and deterioration. This is an area of serious concern, for the protection of life and property, this fireplace and chimney system should not be used for any type of fire.

A.14.3 (Chimney inspection required to ensure).....(5) Chimney or vent and its connector for general suitability....
