# High Mountain Hearth Solutions, Inc.

## Confidential Inspection Report

### Three Seasons Condominiums

N.F.P.A. Level II Chimney Inspection

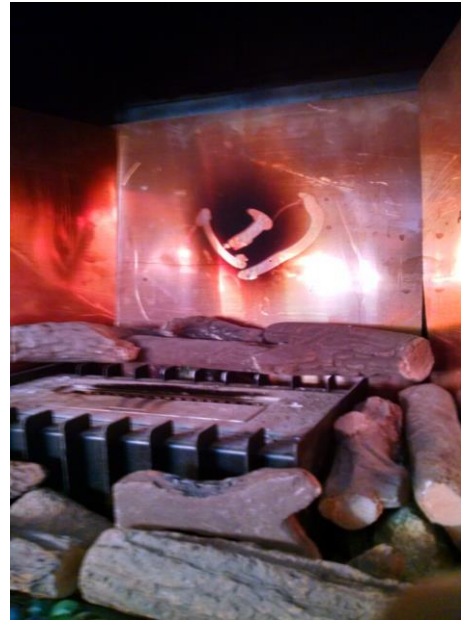
It appears that this fireplace has been set up to burn a gel fire. The firebox baffles on the sides and back of the firebox have been replaced with copper. Copper cannot withstand the high temperatures reached during the course of a wood fire. Because of issues found during the course of this inspection, it is recommended that, for the protection of life and property, this fireplace and chimney system not be used to burn any type of fire.

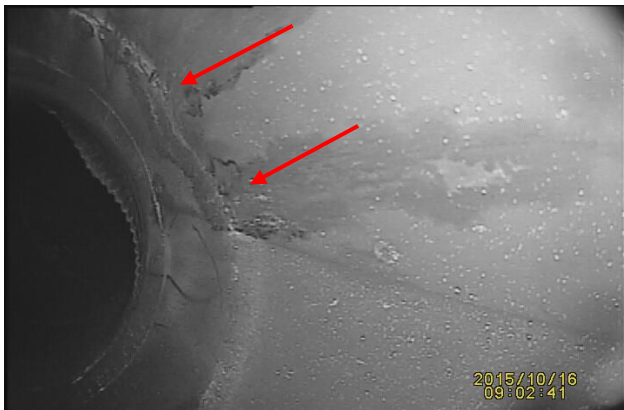
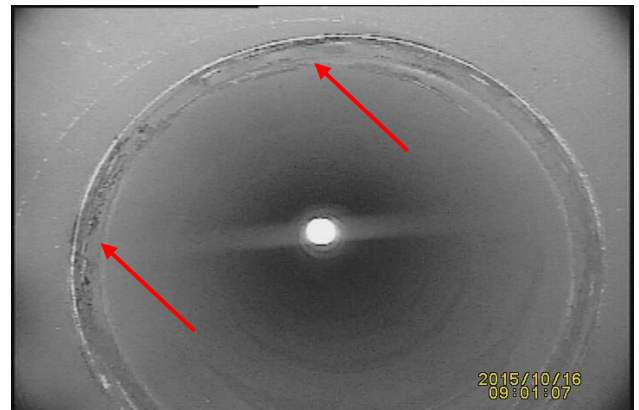
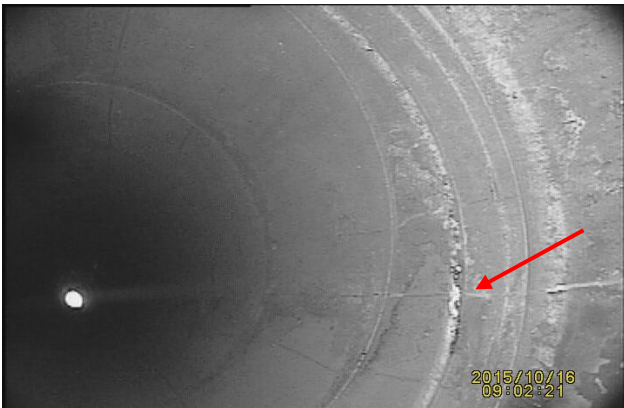
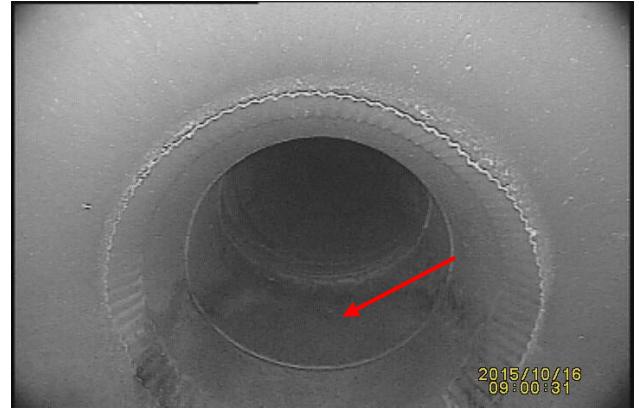
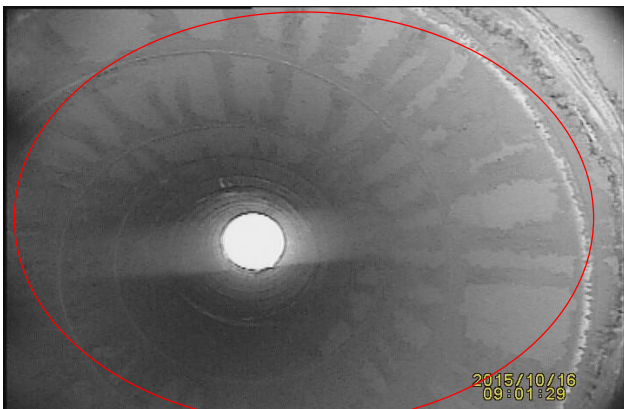
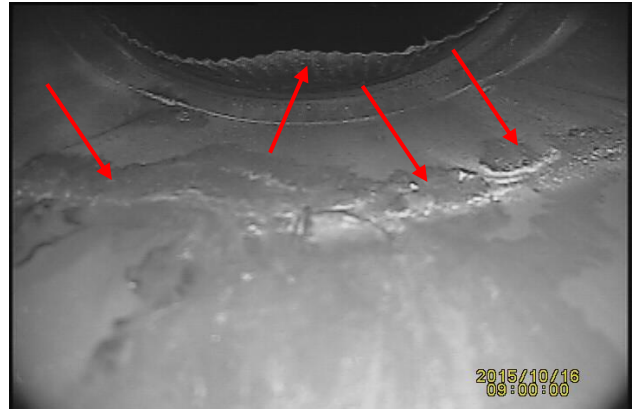
Over time and use, the metals inside the chimney can break down due to the extreme temperatures and the harsh gasses produced during combustion. As seen in the photos below, the video scan of the inside of this chimney shows signs of deterioration. This is an area of serious concern, for the protection of life and property, this fireplace and chimney system should not be used for any type of fire.

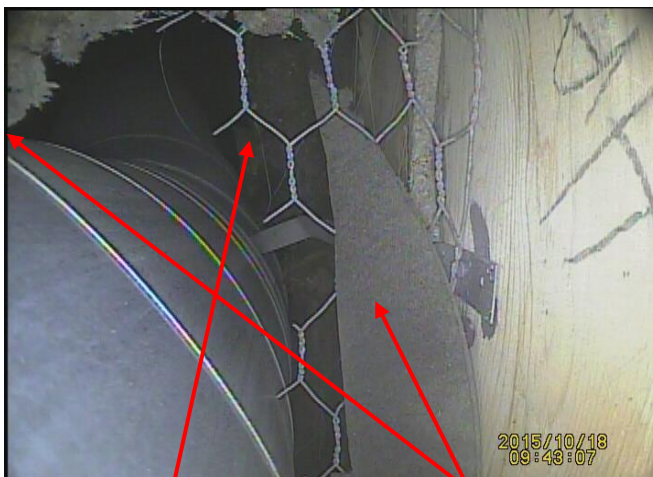
No firestop provided where chimney passes through floor/ceiling

Debris touching chimney, a 2" airspace must be maintained

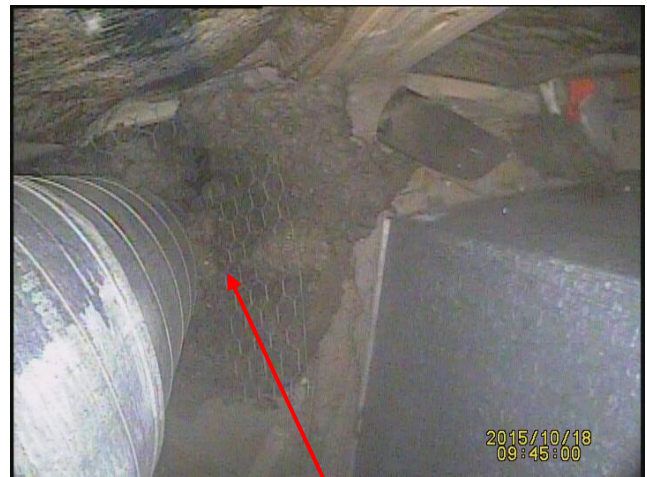
It appears that insulation has been placed on chicken wire in place of an adequate firestop. This is not approved and is a fire hazard
