High Mountain Hearth Solutions, Inc.

Confidential Inspection Report

Three Seasons Condominiums

N.F.P.A. Level II Chimney Inspection

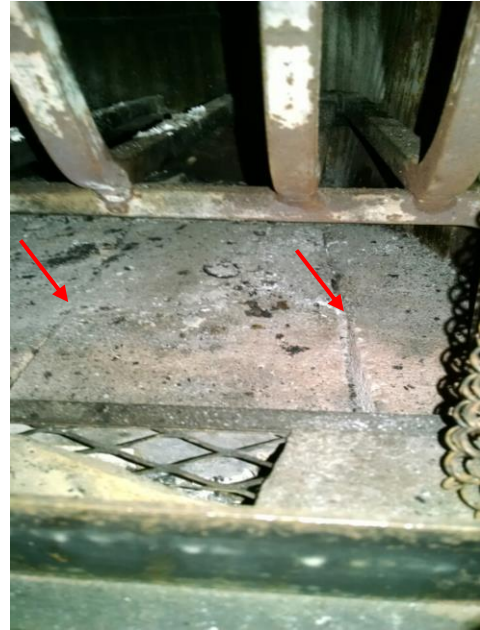
Firebox Floor

The firebox refractory floor is showing cracks from long term use. The purpose of the refractory floor is to help insulate the combustible building materials beneath the fireplace. Firebricks are installed on top of the refractory floor, which is acceptable except there are large cracks between the bricks which could allow heat and/or sparks down in between the bricks. Long term exposure to excessive heat can lower the ignition temperature of the combustible building materials beneath the fireplace, and what may not have been a safety issue in the past could possibly become a fire hazard. Because of this issue, combined with the other issues found in this inspection, it is recommended that, for the protection of life and property, this fireplace and chimney system not be used to burn any type of fire.

A.14.3 (Chimney inspection required to ensure).....(4) General condition of appliance

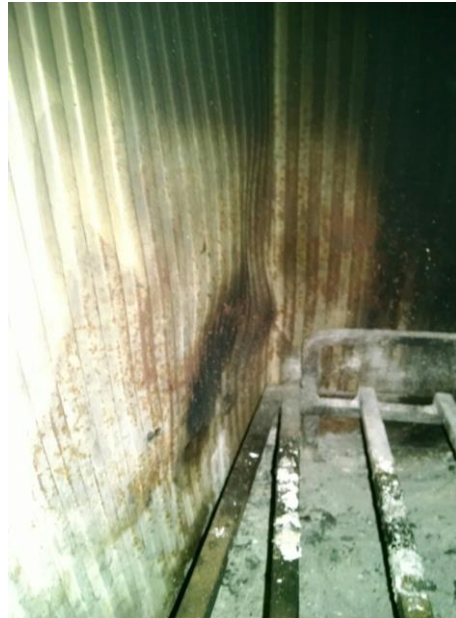
Firebox Baffles

The firebox baffles on the sides and back of the firebox are warping from long term use. The purpose of the baffles is to help provide an insulating airspace between the firebox and the outside of the fireplace, which is next to the combustible framing of the structure. As the baffles continue to warp, the airspace becomes smaller and misshaped, likely reducing the insulating value the airspace behind the baffles provide. Long term exposure to excessive heat can lower the ignition temperature of the combustible building materials around the fireplace, and what may not have been a safety issue in the past could possibly become a fire hazard. Because of this issue, combined with the other issues found in this inspection, it is recommended that, for the protection of life and property, this fireplace and chimney system not be used to burn any type of fire.

A.14.3 (Chimney inspection required to ensure).....(4) General condition of appliance

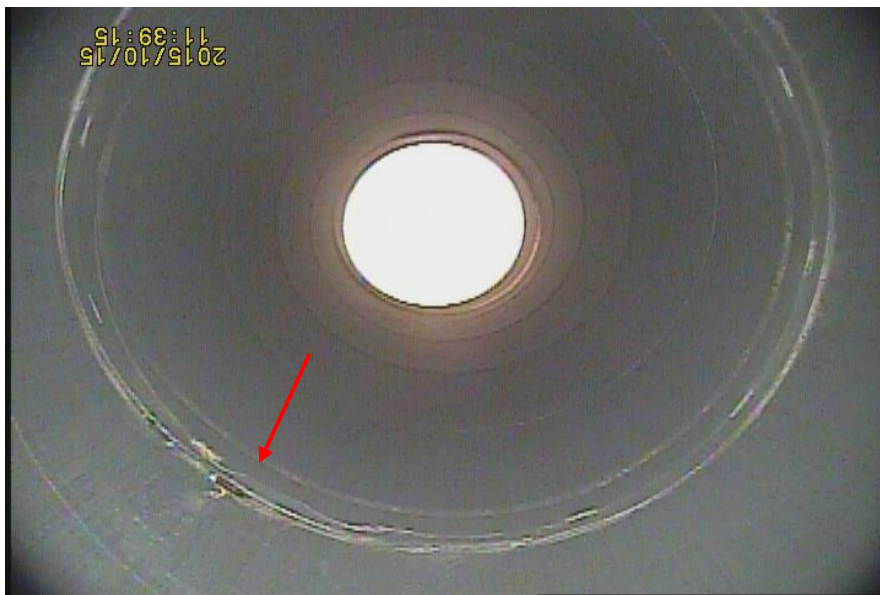
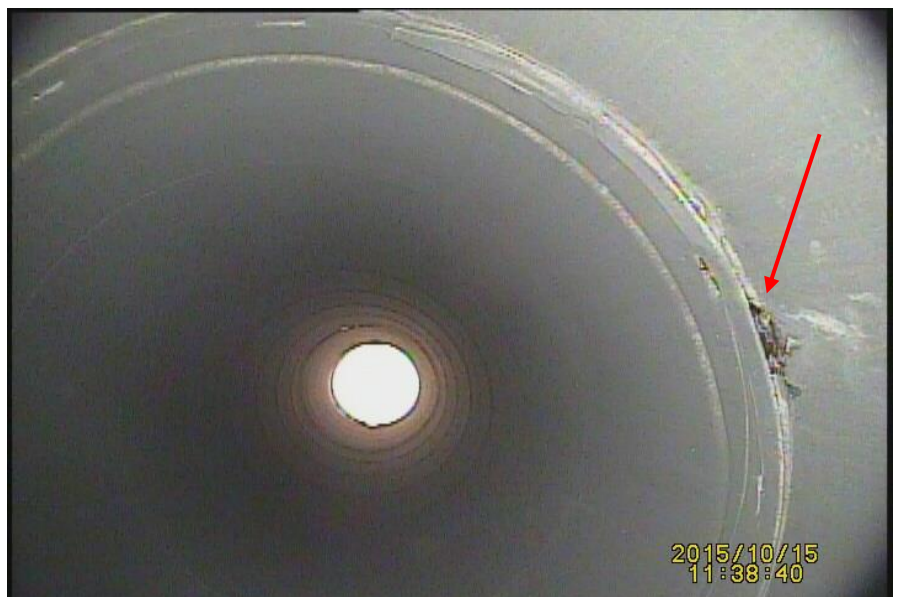
Interior Chimney Scan

Over time and use, the metals inside the chimney can break down due to the extreme temperatures and the harsh gasses produced during combustion. As seen in the photos below, the video scan of the inside of this chimney shows signs of deterioration. This is an area of serious concern, for the protection of life and property, this fireplace and chimney system should not be used for any type of fire.

A.14.3 (Chimney inspection required to ensure).....(5) Chimney or vent and its connector for general suitability....

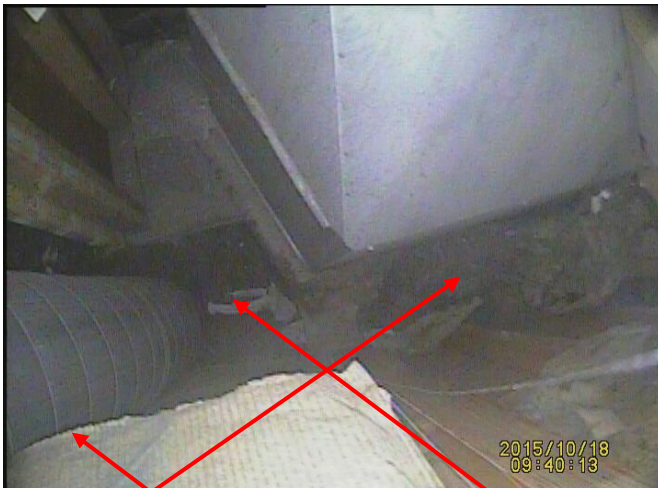
Each time a chimney passes through a floor or ceiling a firestop is required to prevent or slow the spread of flames and smoke in the unfortunate event of a fire. Units on the first floor should have 3 firestops, one at the first floor ceiling, second floor ceiling, and third floor ceiling. Second floor units should have two firestops, and third floor units should have one. Throughout the entire complex we found virtually no adequate firestops. The photos below are representative of the conditions found. This is an area of real concern, for the protection of life and property, this fireplace and chimney system should not be used for any type of fire.

Insulation touching chimney & fireplace, a 2" airspace is required

No firestop provided where chimney passes through floor/ceiling

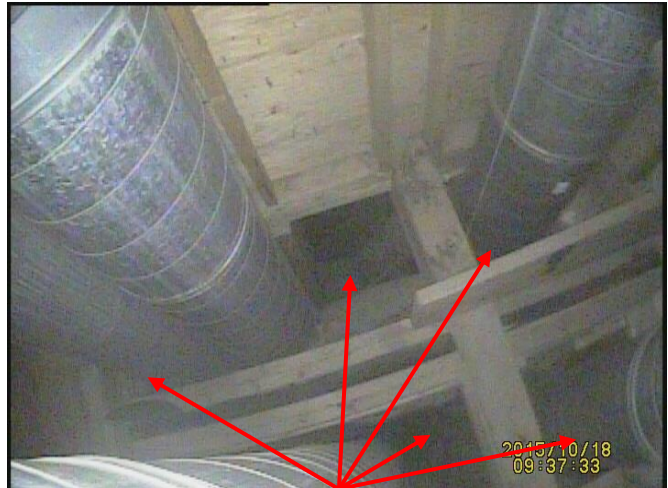
Each chimney must have a firestop where it passes through a floor/ceiling. No firestops have been provided

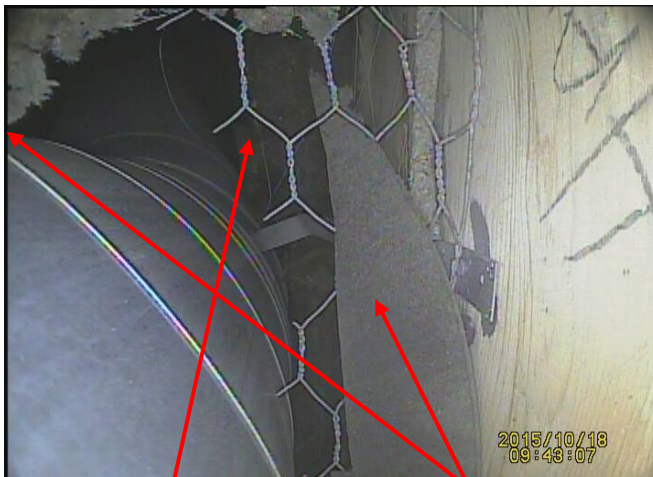
No firestop provided where chimney passes through floor/ceiling

Debris touching chimney, a 2" airspace must be maintained

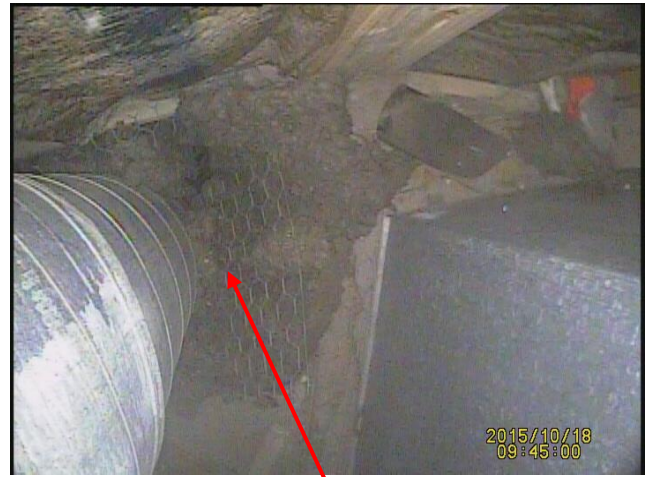
It appears that insulation has been placed on chicken wire in place of an adequate firestop. This is not approved and is a fire hazard
