High Mountain Hearth Solutions, Inc.

Confidential Inspection Report

Three Seasons Condominiums

N.F.P.A. Level II Chimney Inspection

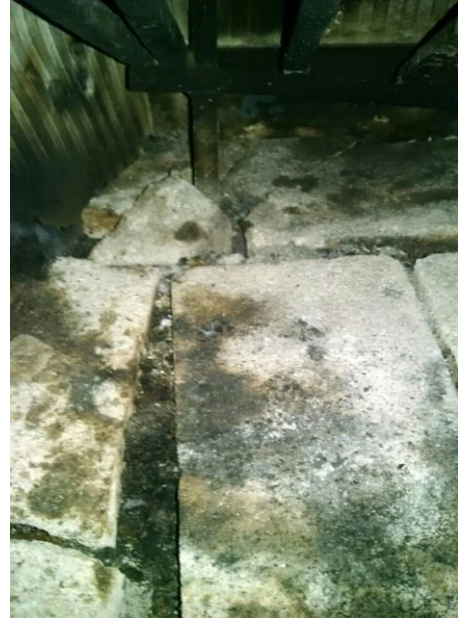
Firebox Floor

The firebox refractory floor is showing cracks from long term use. The purpose of the refractory floor is to help insulate the combustible building materials beneath the fireplace. Firebricks are installed on top of the refractory floor, which is acceptable except there are large cracks between the bricks which could allow heat and/or sparks down in between the bricks. Long term exposure to excessive heat can lower the ignition temperature of the combustible building materials beneath the fireplace, and what may not have been a safety issue in the past could possibly become a fire hazard. Because of this issue, combined with the other issues found in this inspection, it is recommended that, for the protection of life and property, this fireplace and chimney system not be used to burn any type of fire.

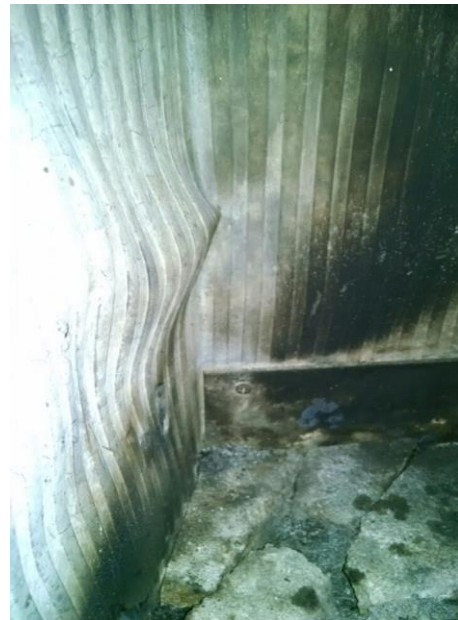
Firebox Baffles

The firebox baffles on the sides and back of the firebox are warping from long term use. The purpose of the baffles is to help provide an insulating airspace between the firebox and the outside of the fireplace, which is next to the combustible framing of the structure. As the baffles continue to warp, the airspace becomes smaller and misshaped, likely reducing the insulating value the airspace behind the baffles provide. Long term exposure to excessive heat can lower the ignition temperature of the combustible building materials around the fireplace, and what may not have been a safety issue in the past could possibly become a fire hazard. Because of this issue, combined with the other issues found in this inspection, it is recommended that, for the protection of life and property, this fireplace and chimney system not be used to burn any type of fire.

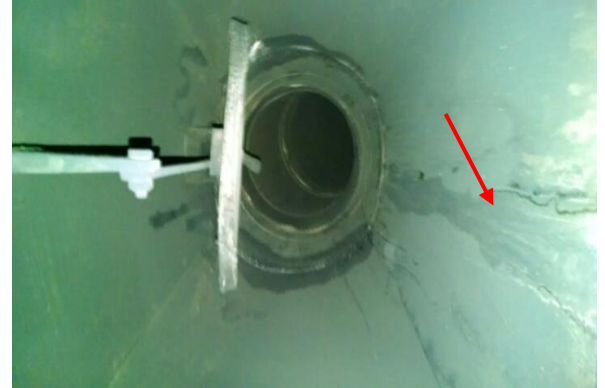
Fireplace Damper

While the damper in this fireplace appears to function as well as can be expected for a fireplace of this age, it has a tendency to 'stick' and take more force to open and/or close than someone unfamiliar with its operation might think. This could possibly lead to a fire being lit without it being confirmed that the damper is in the full open position. The picture to the right shows signs of excessive moisture. Because of this issue, combined with the other issues found in this inspection, it is recommended that for the protection of life and property, this fireplace and chimney system not be used to burn any type of fire.

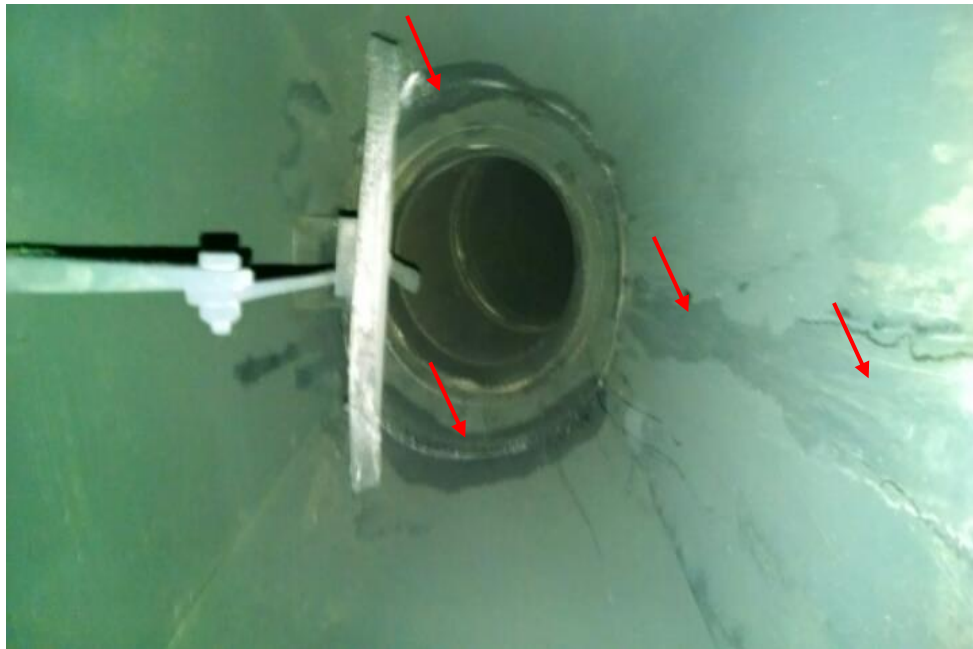
Interior Chimney Scan

Over time and use, the metals inside the chimney can break down due to the extreme temperatures and the harsh gasses produced during combustion. As seen in the photos below, the video scan of the inside of this chimney shows signs of excessive moisture and deterioration. This is an area of serious concern, for the protection of life and property, this fireplace and chimney system should not be used for any type of fire.

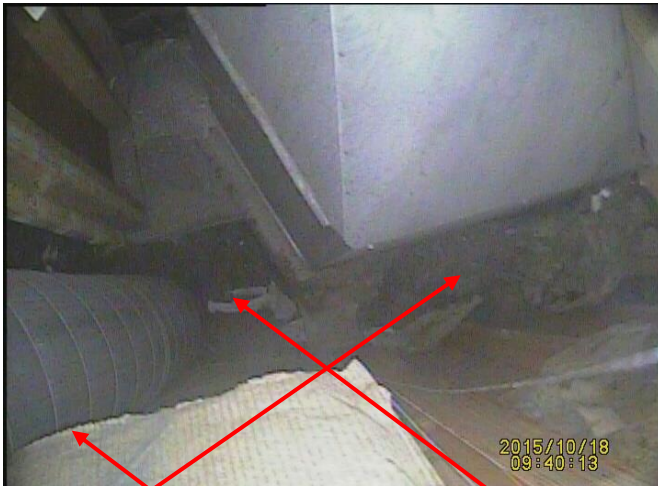
Insulation touching chimney & fireplace, a 2" airspace is required

No firestop provided where chimney passes through floor/ceiling
