# High Mountain Hearth Solutions, Inc.

## Confidential Inspection Report

### Three Seasons Condominiums

N.F.P.A. Level II Chimney Inspection

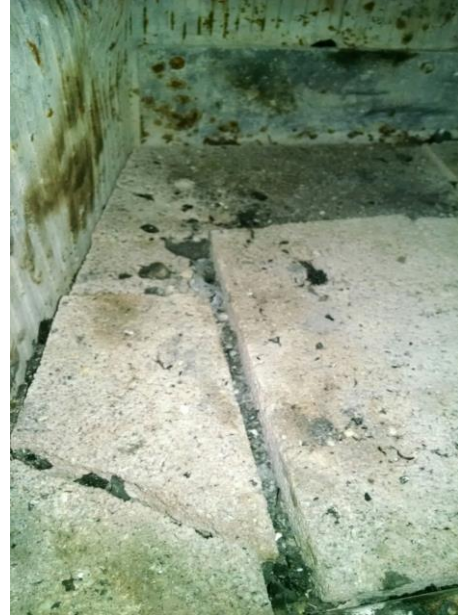
## Firebox Floor

The firebox refractory floor is showing cracks from long term use. The purpose of the refractory floor is to help insulate the combustible building materials beneath the fireplace. Firebricks are installed on top of the refractory floor, which is acceptable except there are large cracks between the bricks which could allow heat and/or sparks down in between the bricks. Long term exposure to excessive heat can lower the ignition temperature of the combustible building materials beneath the fireplace, and what may not have been a safety issue in the past could possibly become a fire hazard. Because of this issue, combined with the other issues found in this inspection, it is recommended that, for the protection of life and property, this fireplace and chimney system not be used to burn any type of fire.

A.14.3 (Chimney inspection required to ensure)....(4) General condition of appliance

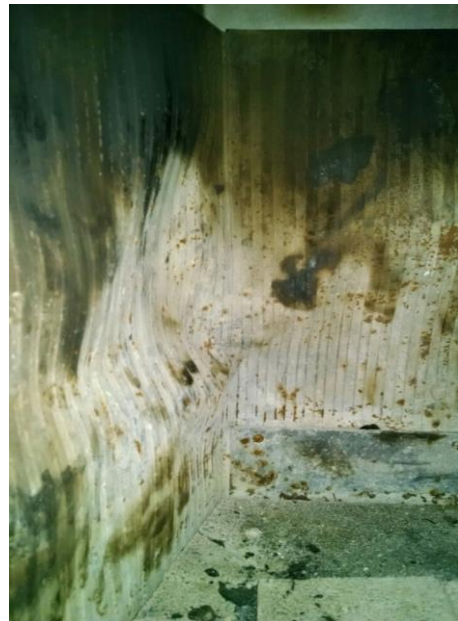
## Firebox Baffles

The firebox baffles on the sides and back of the firebox are warping from long term use. The purpose of the baffles is to help provide an insulating airspace between the firebox and the outside of the fireplace, which is next to the combustible framing of the structure. As the baffles continue to warp, the airspace becomes smaller and misshaped, likely reducing the insulating value the airspace behind the baffles provide. Long term exposure to excessive heat can lower the ignition temperature of the combustible building materials around the fireplace, and what may not have been a safety issue in the past could possibly become a fire hazard. Because of this issue, combined with the other issues found in this inspection, it is recommended that, for the protection of life and property, this fireplace and chimney system not be used to burn any type of fire.

A.14.3 (Chimney inspection required to ensure)....(4) General condition of appliance

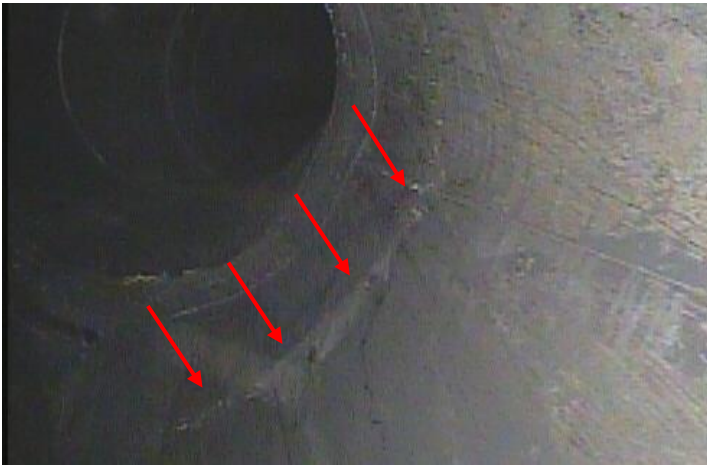
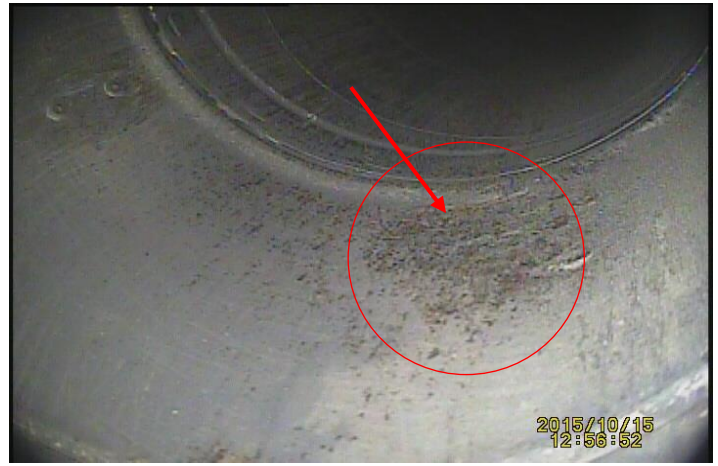
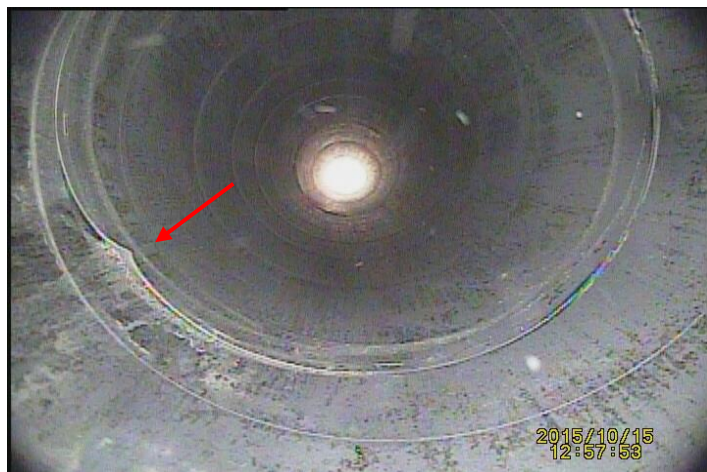
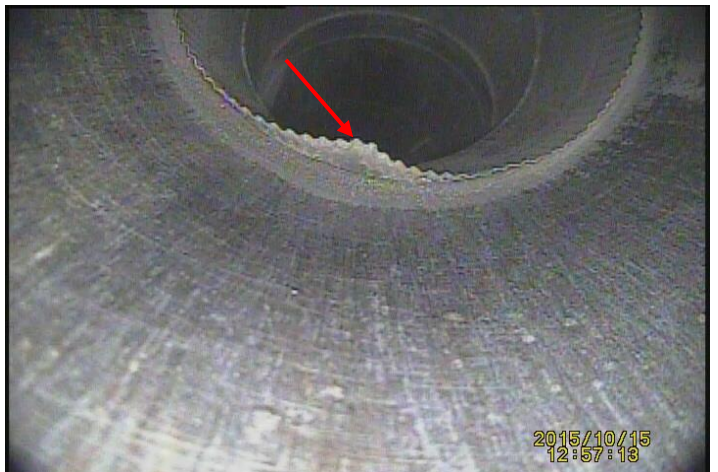
## Interior Chimney Scan

Over time and use, the metals inside the chimney can break down due to the extreme temperatures and the harsh gasses produced during combustion. As seen in the photos below, the video scan of the inside of this chimney shows signs of deterioration and defective joints. This is an area of serious concern, for the protection of life and property, this fireplace and chimney system should not be used for any type of fire.

A.14.3 (Chimney inspection required to ensure)....(5) Chimney or vent and its connector for general suitability....

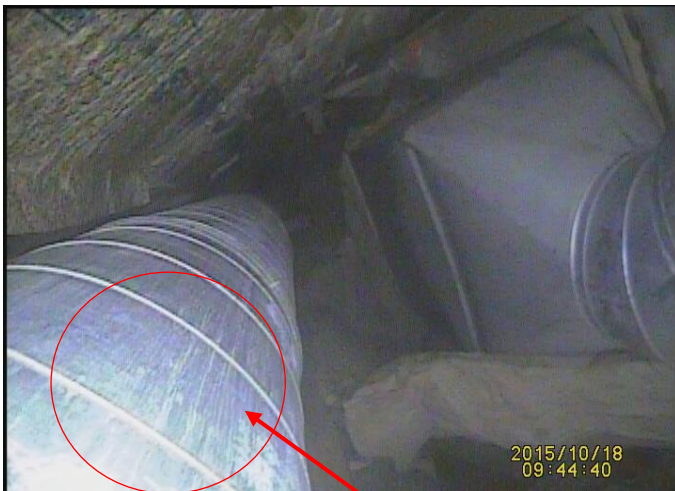
Many of the chimneys in this complex show evidence of moisture on the outside of the outer wall of the chimney. Judging by how the moisture entered and exited the different layers at the joints of the chimneys, it is evident that the moisture has been both on the inside and outside of the outer wall of the chimney. Over time, moisture can break down the integrity of the walls and joints of the chimney, weakening the system and making it unsafe to use. The photos below are representative of the conditions found.

Lines of moisture running in and out of the seams of the outer wall of the chimney

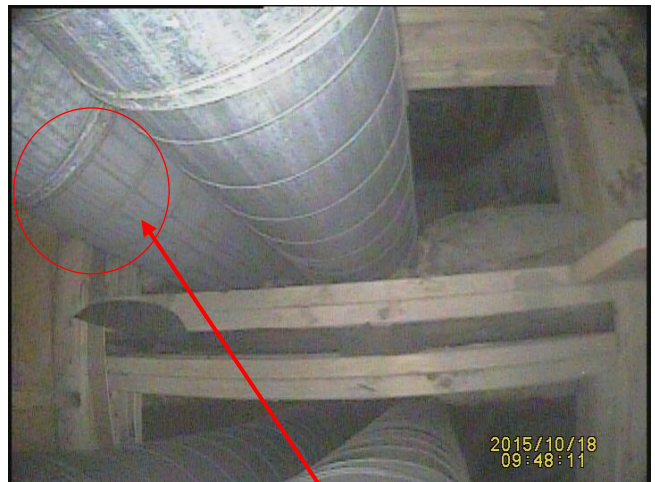
Lines of moisture running in and out of the seams of the outer wall of the chimney

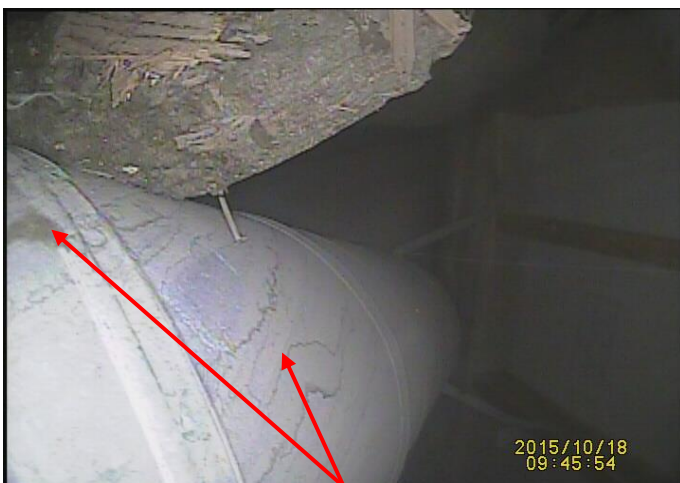
Signs of moisture presents on the outer wall of the chimney

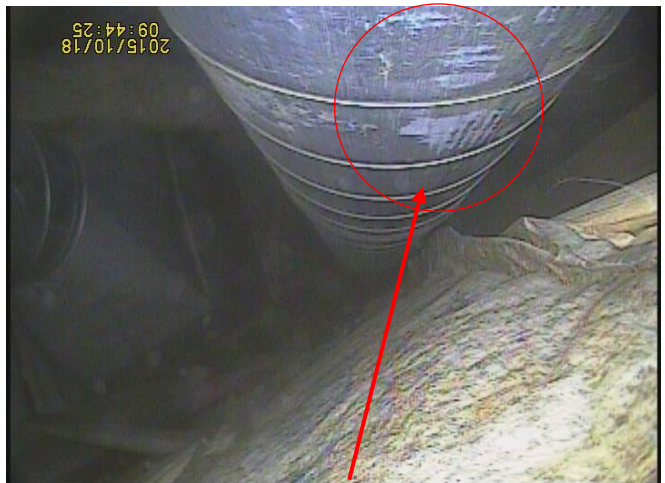
Signs of moisture damage on the outer wall of the chimney

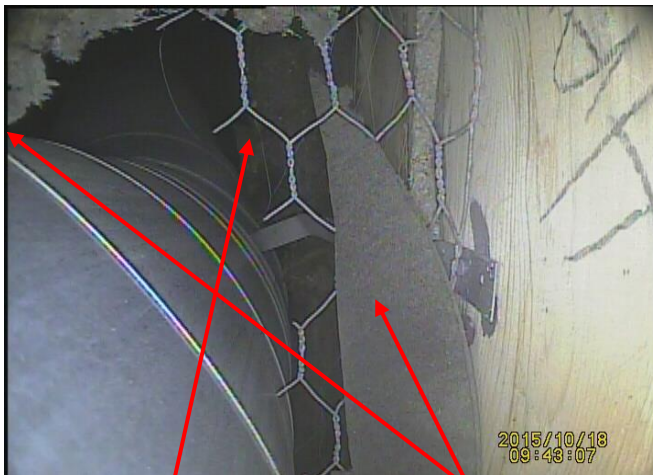
No firestop provided where chimney passes through floor/ceiling

Debris touching chimney, a 2" airspace must be maintained

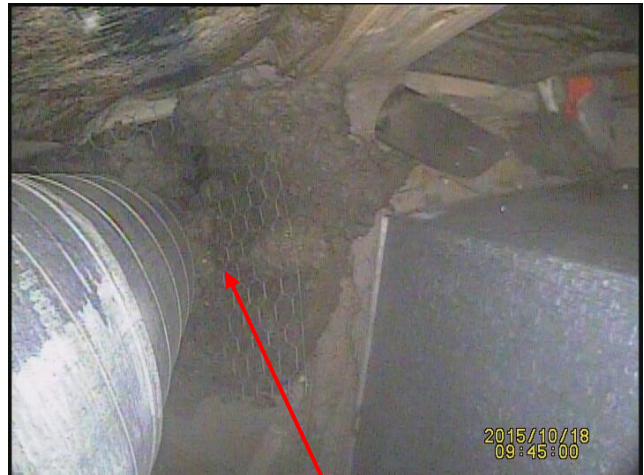
It appears that insulation has been placed on chicken wire in place of an adequate firestop. This is not approved and is a fire hazard

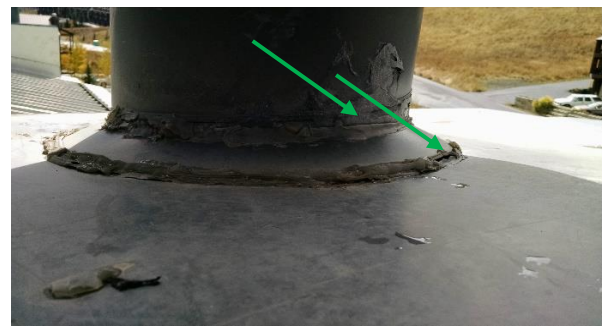
## Chase Top Termination

The storm collar seal on the chimneys in these chases is no longer keeping out all of the moisture. This type of flashing construction relies on temporary seals like tar or silicone to keep moisture from entering the structure, and these components break down over time, as is the case with these chase covers. If constructed differently, a soldered joint is the primary barrier which keeps the moisture out of the chase. A short term fix would be to reseal the existing storm collars, but it is recommended that in the near future the chase covers be replaced with covers that have a soldered collar in place as the primary defense against moisture. The photos below are representative of the conditions found.
