High Mountain Hearth Solutions, Inc.

Confidential Inspection Report

Three Seasons Condominiums

N.F.P.A. Level II Chimney Inspection

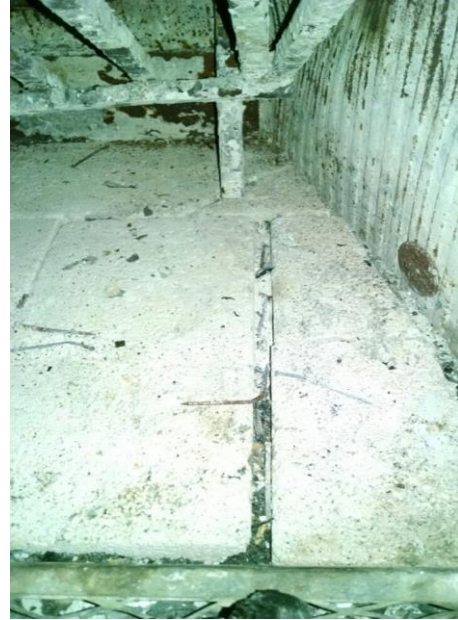
Firebox Floor

The firebox refractory floor is showing cracks from long term use. The purpose of the refractory floor is to help insulate the combustible building materials beneath the fireplace. Firebricks are installed on top of the refractory floor, which is acceptable except there are large cracks between the bricks which could allow heat and/or sparks down in between the bricks. Long term exposure to excessive heat can lower the ignition temperature of the combustible building materials beneath the fireplace, and what may not have been a safety issue in the past could possibly become a fire hazard. Because of this issue, combined with the other issues found in this inspection, it is recommended that, for the protection of life and property, this fireplace and chimney system not be used to burn any type of fire.

A.14.3 (Chimney inspection required to ensure).....(4) General condition of appliance

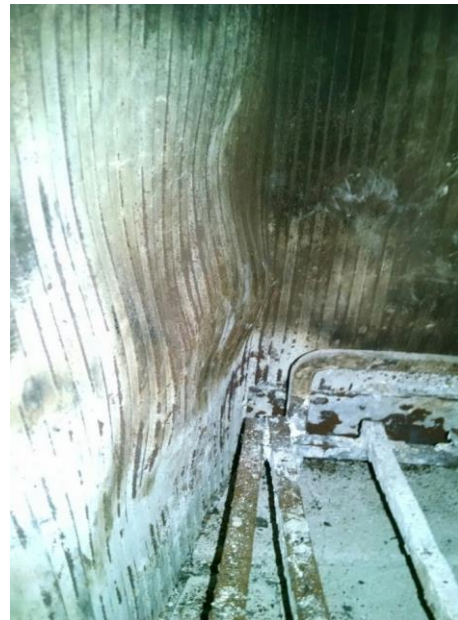
Firebox Baffles

The firebox baffles on the sides and back of the firebox are warping from long term use. The purpose of the baffles is to help provide an insulating airspace between the firebox and the outside of the fireplace, which is next to the combustible framing of the structure. As the baffles continue to warp, the airspace becomes smaller and misshaped, likely reducing the insulating value the airspace behind the baffles provide. Long term exposure to excessive heat can lower the ignition temperature of the combustible building materials around the fireplace, and what may not have been a safety issue in the past could possibly become a fire hazard. Because of this issue, combined with the other issues found in this inspection, it is recommended that, for the protection of life and property, this fireplace and chimney system not be used to burn any type of fire.

A.14.3 (Chimney inspection required to ensure).....(4) General condition of appliance

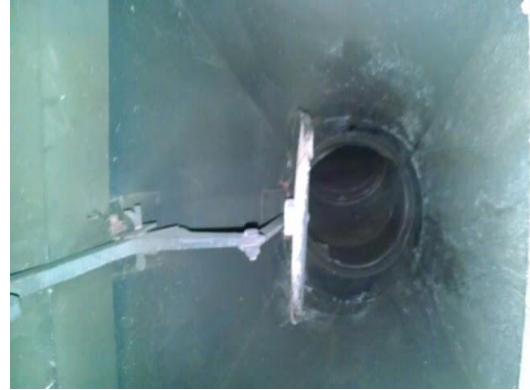
Fireplace Damper

While the damper in this fireplace appears to function as well as can be expected for a fireplace of this age, it has a tendency to 'stick' and take more force to open and/or close than someone unfamiliar with its operation might think. This could possibly lead to a fire being lit without it being confirmed that the damper is in the full open position. Because of this issue, combined with the other issues found in this inspection, it is recommended that for the protection of life and property, this fireplace and chimney system not be used to burn any type of fire.

A.14.3 (Chimney inspection required to ensure).....(27) Operation and closure of damper assembly

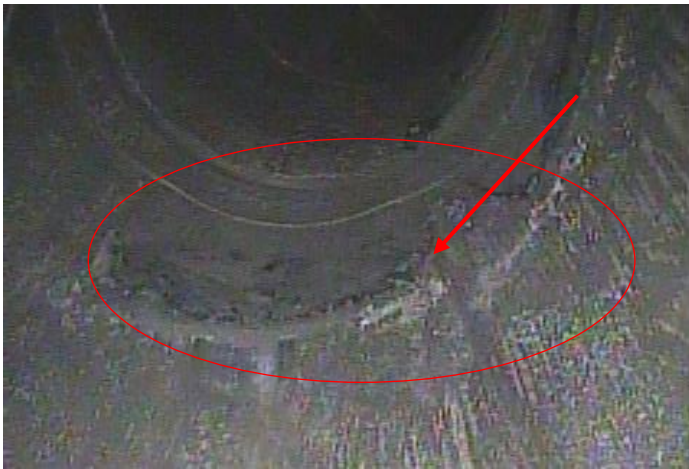
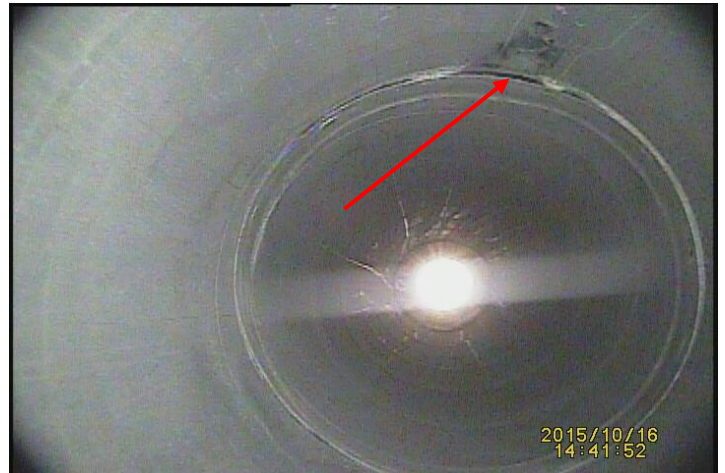
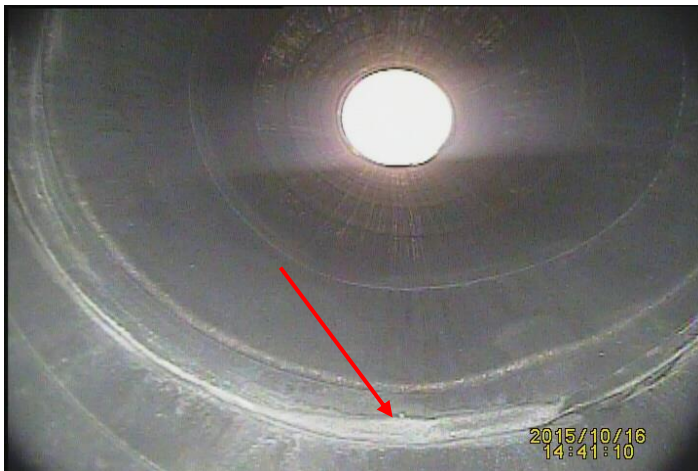
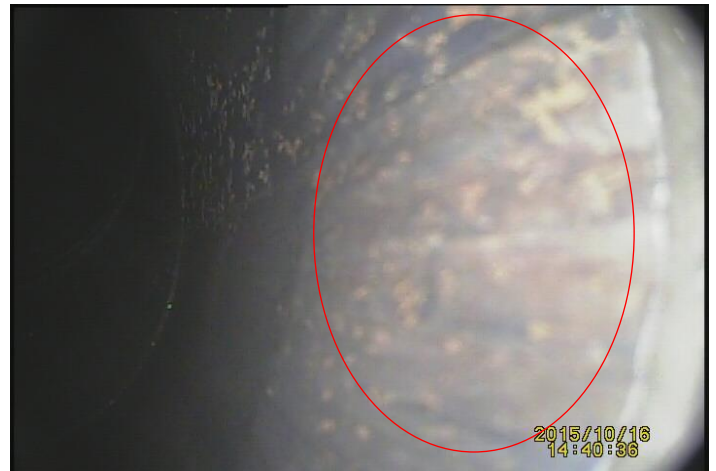
Interior Chimney Scan

Over time and use, the metals inside the chimney can break down due to the extreme temperatures and the harsh gasses produced during combustion. As seen in the photos below, the video scan of the inside of this chimney shows signs of deterioration. This is an area of serious concern, for the protection of life and property, this fireplace and chimney system should not be used for any type of fire.

A.14.3 (Chimney inspection required to ensure).....(5) Chimney or vent and its connector for general suitability....

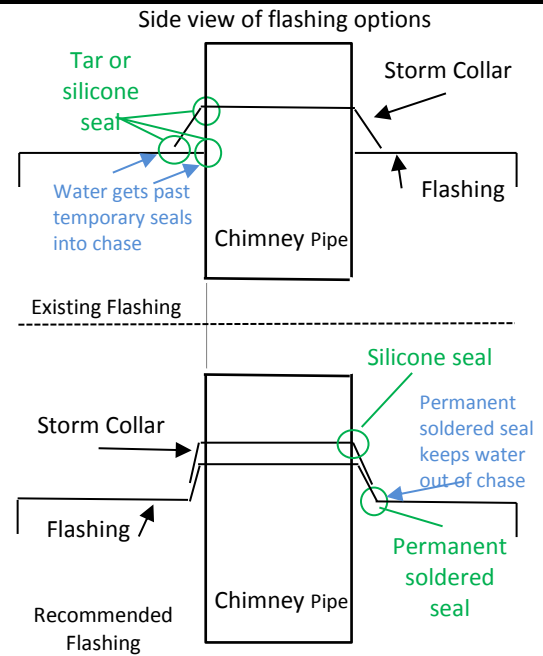
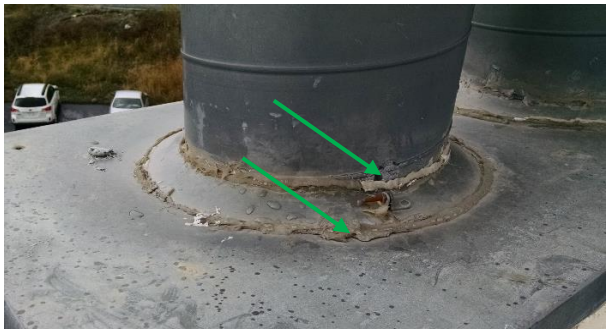
Chase Top Termination

The storm collar seal on the chimneys in these chases is no longer keeping out all of the moisture. This type of flashing construction relies on temporary seals like tar or silicone to keep moisture from entering the structure, and these components break down over time, as is the case with these chase covers. If constructed differently, a soldered joint is the primary barrier which keeps the moisture out of the chase. A short term fix would be to reseal the existing storm collars, but it is recommended that in the near future the chase covers be replaced with covers that have a soldered collar in place as the primary defense against moisture. The photos below are representative of the conditions found.
