Confidential Inspection Report

Three Seasons Condominiums

340

N.F.P.A. Level II Chimney Inspection

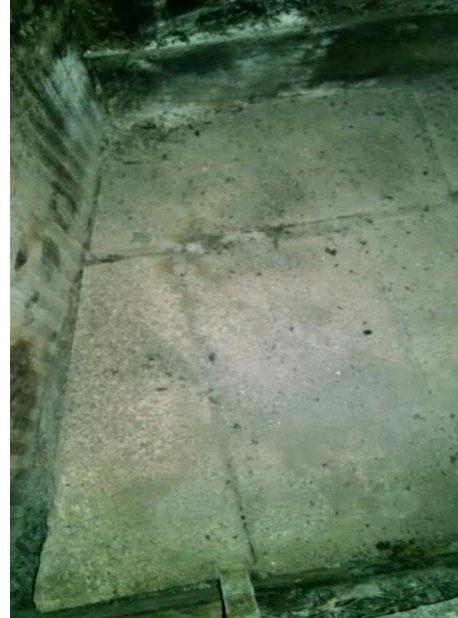
Firebox Floor

The firebox refractory floor is showing cracks from long term use. The purpose of the refractory floor is to help insulate the combustible building materials beneath the fireplace. Firebricks are installed on top of the refractory floor, which is acceptable except there are large cracks between the bricks which could allow heat and/or sparks down in between the bricks. Long term exposure to excessive heat can lower the ignition temperature of the combustible building materials beneath the fireplace, and what may not have been a safety issue in the past could possibly become a fire hazard. Because of this issue, combined with the other issues found in this inspection, it is recommended that, for the protection of life and property, this fireplace and chimney system not be used to burn any type of fire.

A.14.3 (Chimney inspection required to ensure).....(4) General condition of appliance

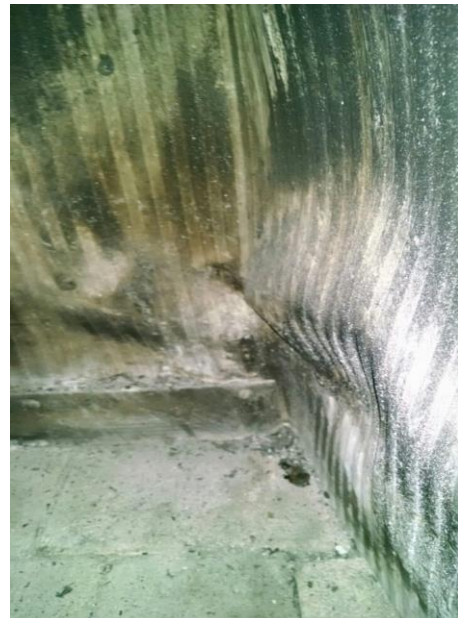
Firebox Baffles

The firebox baffles on the sides and back of the firebox are warping from long term use. The purpose of the baffles is to help provide an insulating airspace between the firebox and the outside of the fireplace, which is next to the combustible framing of the structure. As the baffles continue to warp, the airspace becomes smaller and misshaped, likely reducing the insulating value the airspace behind the baffles provide. Long term exposure to excessive heat can lower the ignition temperature of the combustible building materials around the fireplace, and what may not have been a safety issue in the past could possibly become a fire hazard. Because of this issue, combined with the other issues found in this inspection, it is recommended that, for the protection of life and property, this fireplace and chimney system not be used to burn any type of fire.

A.14.3 (Chimney inspection required to ensure).....(4) General condition of appliance

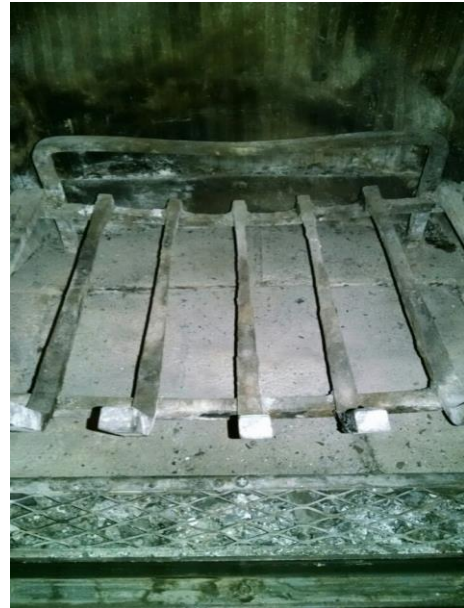
Fireplace Grate

Deteriorated Grate

The grate in this fireplace is partially burned through. This grate should be replaced in the near future.

A.14.3 (Chimney inspection required to ensure).....(32) Freedom from rust or corrosion of readily accessible metal parts in factory-built fireplaces and chimneys

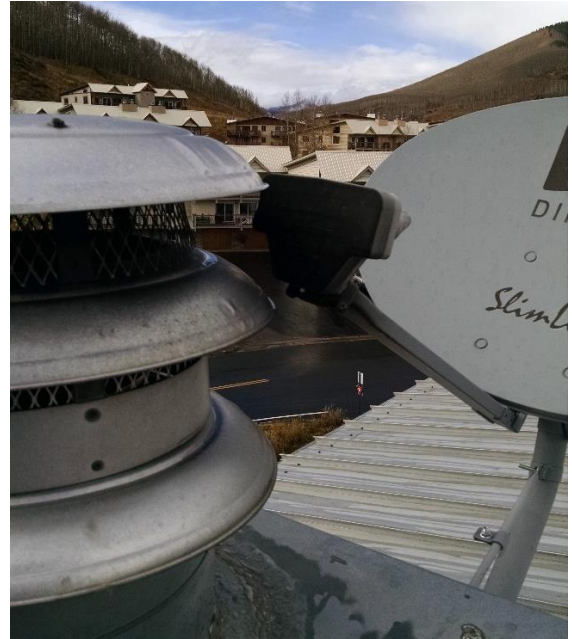
Chimney Termination Clearance

Inadequate Clearance

A satellite dish has been mounted within inches of this chimney termination. This dish has sensitive electronic components that will no doubt be damaged by long term exposure to the heat and smoke from this chimney. There is already damage evident on the receiver. It is recommended this dish be moved to prevent further property damage.

A.14.4 (Chimney inspection required to ensure).....(7) Factory-built chimney and factory-built fireplace chimney clearances

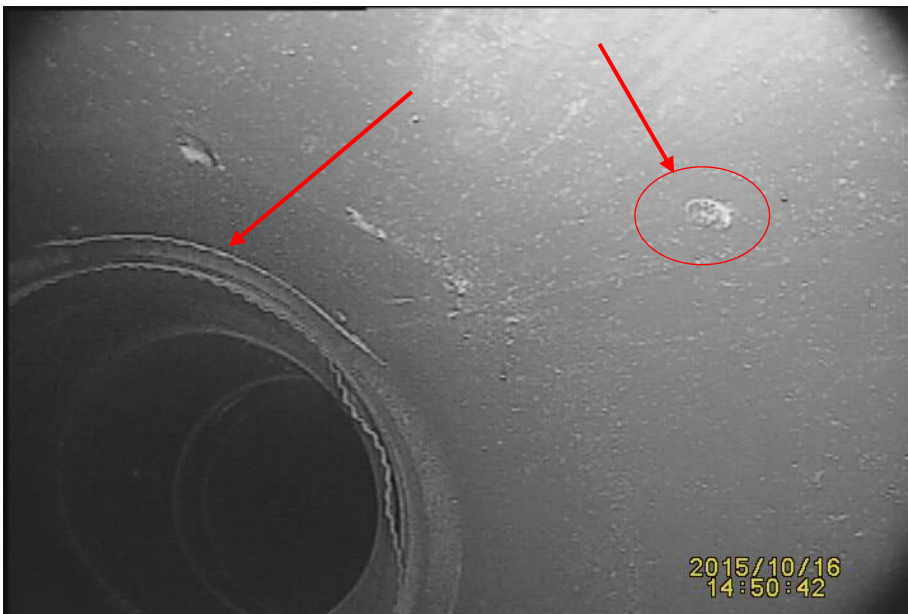
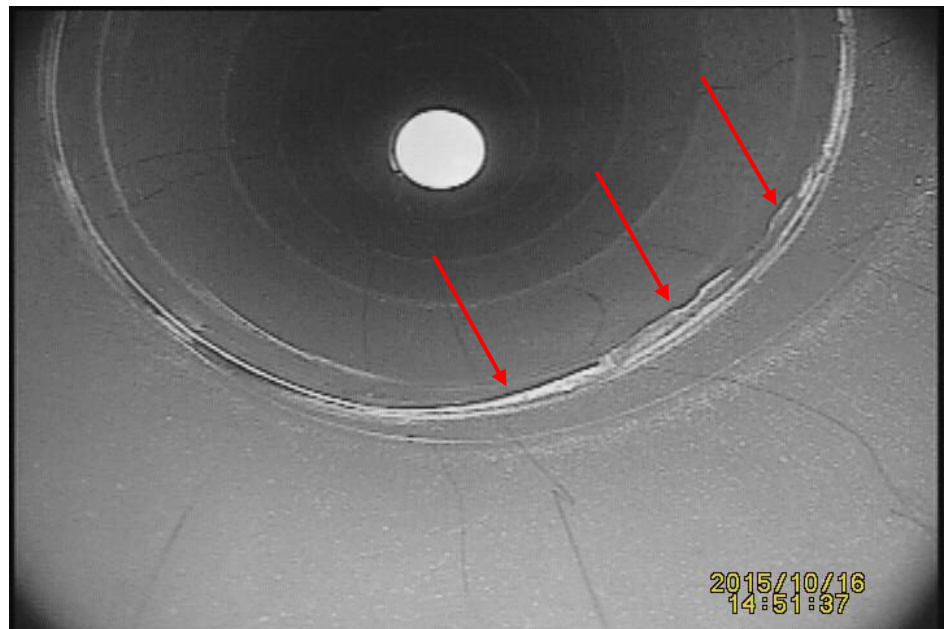
Interior Chimney Scan

Over time and use, the metals inside the chimney can break down due to the extreme temperatures and the harsh gasses produced during combustion. As seen in the photos below, the video scan of the inside of this chimney shows signs of deterioration & weakening of the seams of the chimney liner. This is an area of serious concern, for the protection of life and property, this fireplace and chimney system should not be used for any type of fire.

A.14.3 (Chimney inspection required to ensure).....(5) Chimney or vent and its connector for general suitability....
