High Mountain Hearth Solutions, Inc.

Confidential Inspection Report

Three Seasons Condominiums

N.F.P.A. Level II Chimney Inspection

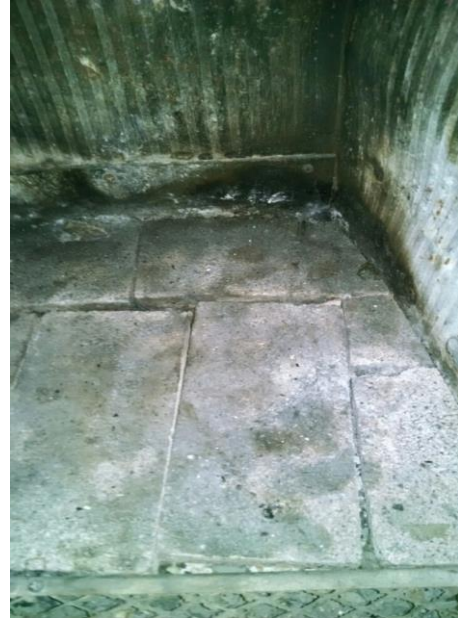
Firebox Floor

The firebox refractory floor is showing cracks from long term use. The purpose of the refractory floor is to help insulate the combustible building materials beneath the fireplace. Firebricks are installed on top of the refractory floor, which is acceptable except there are large cracks between the bricks which could allow heat and/or sparks down in between the bricks. Long term exposure to excessive heat can lower the ignition temperature of the combustible building materials beneath the fireplace, and what may not have been a safety issue in the past could possibly become a fire hazard. Because of this issue, combined with the other issues found in this inspection, it is recommended that, for the protection of life and property, this fireplace and chimney system not be used to burn any type of fire.

A.14.3 (Chimney inspection required to ensure)....(4) General condition of appliance

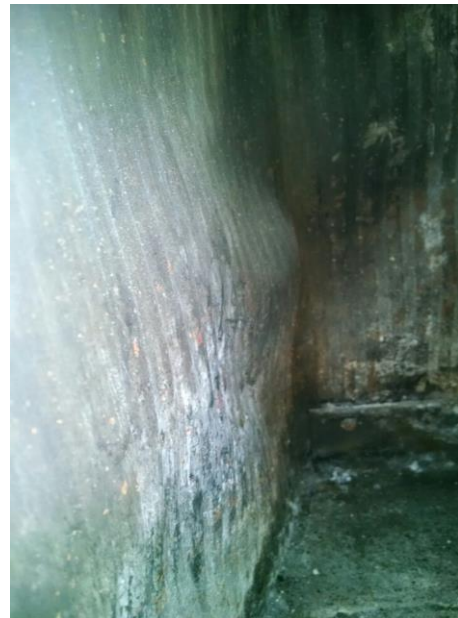
Firebox Baffles

The firebox baffles on the sides and back of the firebox are warping from long term use. The purpose of the baffles is to help provide an insulating airspace between the firebox and the outside of the fireplace, which is next to the combustible framing of the structure. As the baffles continue to warp, the airspace becomes smaller and misshaped, likely reducing the insulating value the airspace behind the baffles provide. Long term exposure to excessive heat can lower the ignition temperature of the combustible building materials around the fireplace, and what may not have been a safety issue in the past could possibly become a fire hazard. Because of this issue, combined with the other issues found in this inspection, it is recommended that, for the protection of life and property, this fireplace and chimney system not be used to burn any type of fire.

A.14.3 (Chimney inspection required to ensure)....(4) General condition of appliance

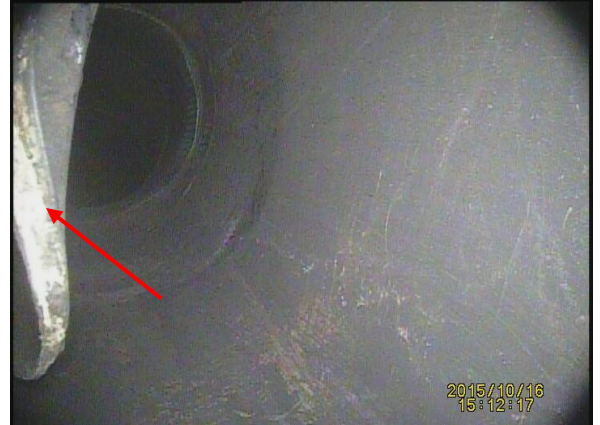
Fireplace Damper

The damper in this fireplace has been bent totally out of shape and no longer can perform the function of a damper. Because of this issue combined with the other issues found in this inspection, it is recommended that for the protection of life and property, this fireplace and chimney system not be used to burn any type of fire.

A.14.3 (Chimney inspection required to ensure)....(27) Operation and closure of damper assembly

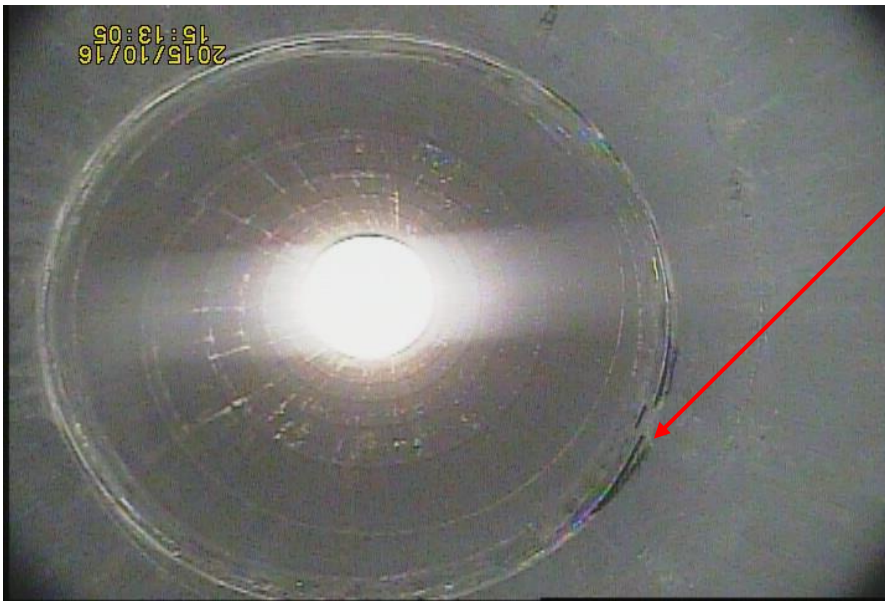
Over time and use, the metals inside the chimney can break down due to the extreme temperatures and the harsh gasses produced during combustion. As seen in the photos below, the video scan of the inside of this chimney shows signs of deterioration. This is an area of serious concern, for the protection of life and property, this fireplace and chimney system should not be used for any type of fire.

Inconsistencies likely due to deterioration found at the joint inside the chimney

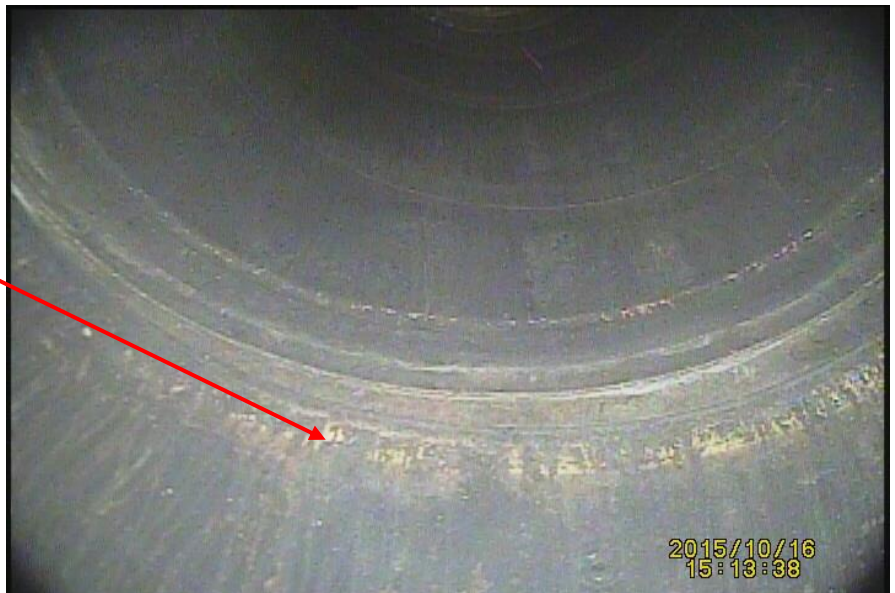
Rusting found inside the chimney

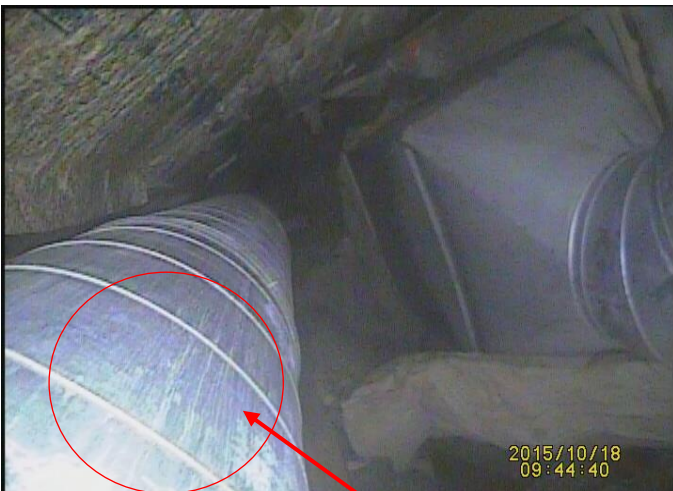
Many of the chimneys in this complex show evidence of moisture on the outside of the outer wall of the chimney. Judging by how the moisture entered and exited the different layers at the joints of the chimneys, it is evident that the moisture has been both on the inside and outside of the outer wall of the chimney. Over time, moisture can break down the integrity of the walls and joints of the chimney, weakening the system and making it unsafe to use.

Lines of moisture running in and out of the seams of the outer wall of the chimney

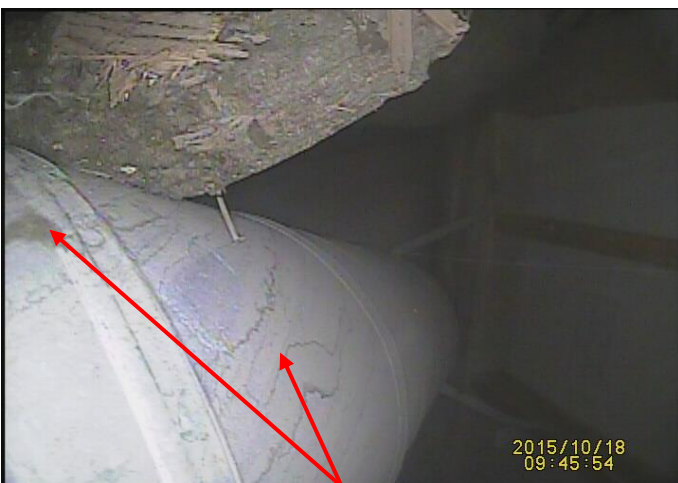
Signs of moisture presents on the outer wall of the chimney

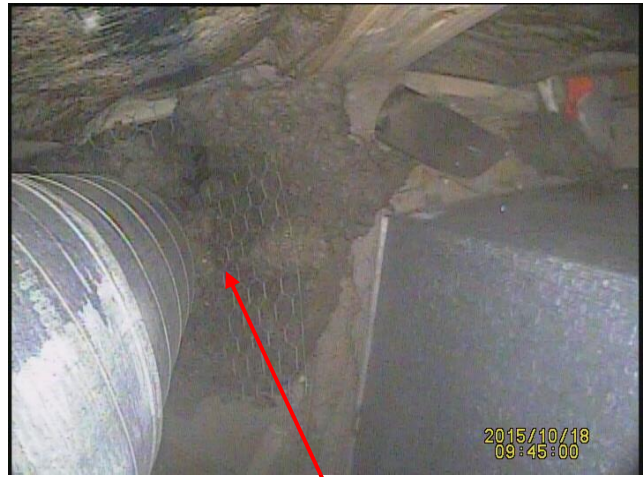
It appears that insulation has been placed on chicken wire in place of an adequate firestop. This is not approved and is a fire hazard

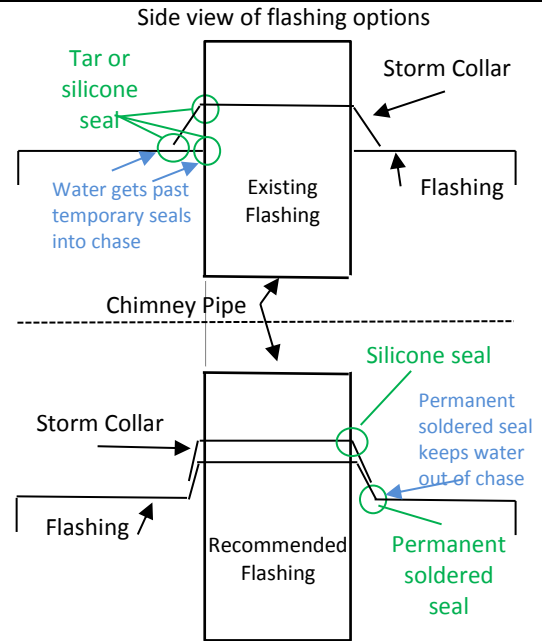
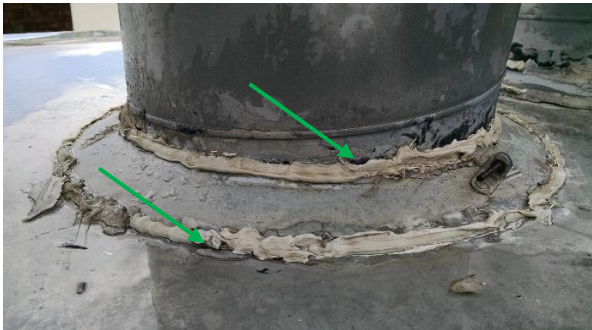
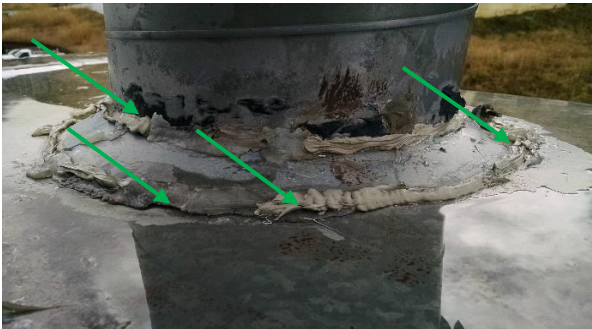
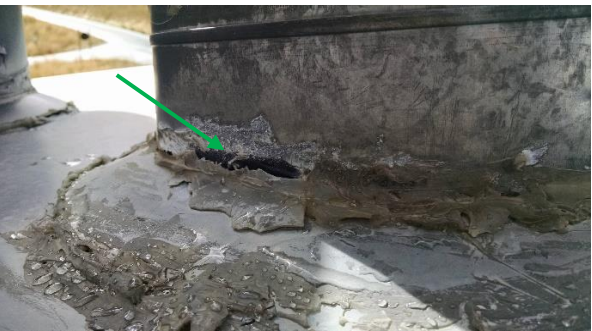
Inadequate Seal

The storm collar seal on the chimneys in these chases is no longer keeping out all of the moisture. This type of flashing construction relies on temporary seals like tar or silicone to keep moisture from entering the structure, and these components break down over time, as is the case with these chase covers. If constructed differently, a soldered joint is the primary barrier which keeps the moisture out of the chase. A short term fix would be to reseal the existing storm collars, but it is recommended that in the near future the chase covers be replaced with covers that have a soldered collar in place as the primary defense against moisture.
