Confidential Inspection Report

Three Seasons Condominiums

701 Gothic Rd
Mt Crested Butte, CO 81225

N.F.P.A. Level II Chimney Inspection

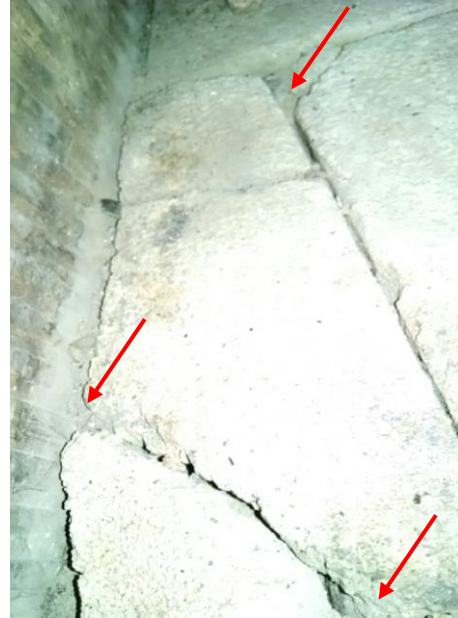
Firebox Floor

The firebox refractory floor is showing cracks from long term use. The purpose of the refractory floor is to help insulate the combustible building materials beneath the fireplace. Firebricks are installed on top of the refractory floor, which is acceptable except there are large cracks between the bricks which could allow heat and/or sparks down in between the bricks. Long term exposure to excessive heat can lower the ignition temperature of the combustible building materials beneath the fireplace, and what may not have been a safety issue in the past could possibly become a fire hazard. Because of this issue, combined with the other issues found in this inspection, it is recommended that, for the protection of life and property, this fireplace and chimney system not be used to burn any type of fire.

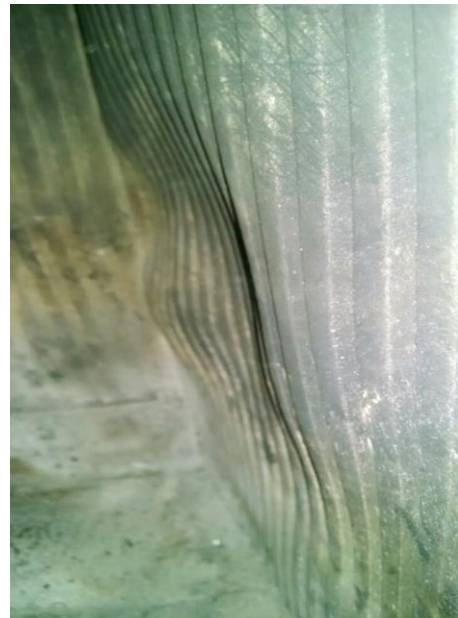
Firebox Baffles

The firebox baffles on the sides and back of the firebox are warping from long term use. The purpose of the baffles is to help provide an insulating airspace between the firebox and the outside of the fireplace, which is next to the combustible framing of the structure. As the baffles continue to warp, the airspace becomes smaller and misshaped, likely reducing the insulating value the airspace behind the baffles provide. Long term exposure to excessive heat can lower the ignition temperature of the combustible building materials around the fireplace, and what may not have been a safety issue in the past could possibly become a fire hazard. Because of this issue, combined with the other issues found in this inspection, it is recommended that, for the protection of life and property, this fireplace and chimney system not be used to burn any type of fire.

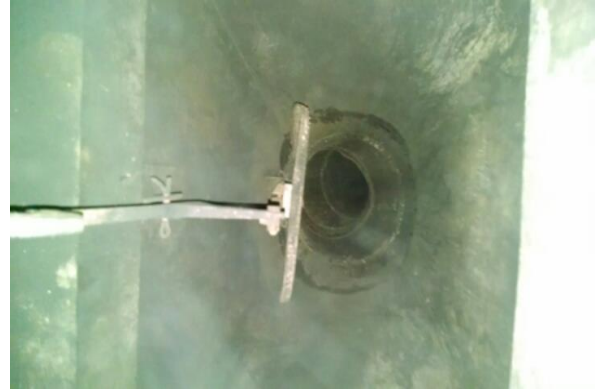
Fireplace Damper

While the damper in this fireplace appears to function as well as can be expected for a fireplace of this age, it has a tendency to 'stick' and take more force to open and/or close than someone unfamiliar with its operation might think. This could possibly lead to a fire being lit without it being confirmed that the damper is in the full open position. Because of this issue, combined with the other issues found in this inspection, it is recommended that for the protection of life and property, this fireplace and chimney system not be used to burn any type of fire.

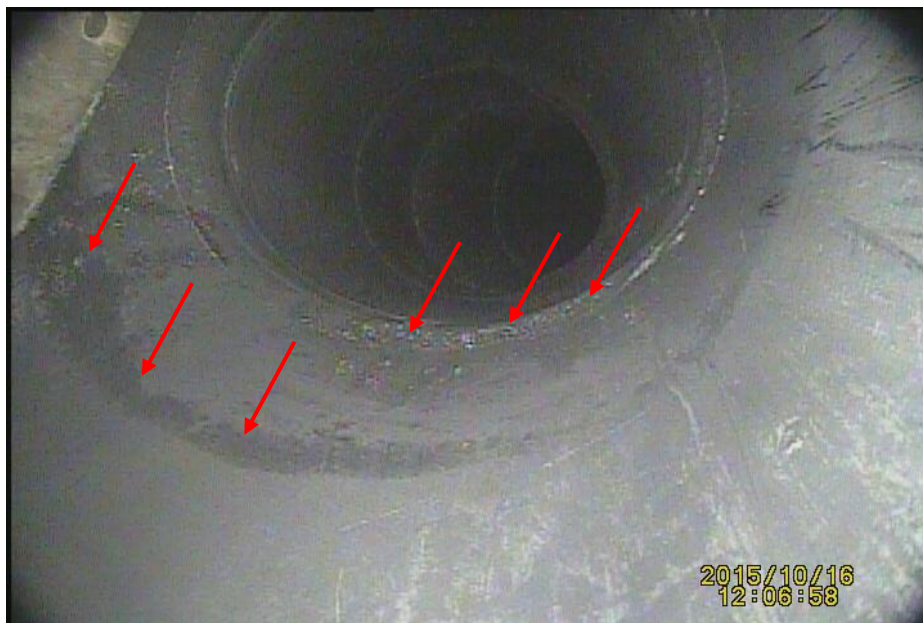
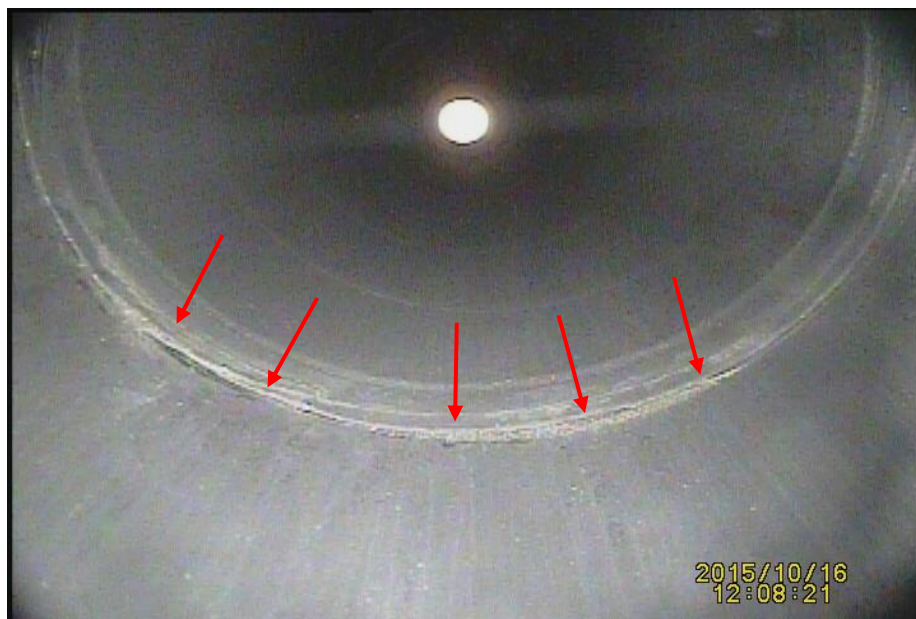
Interior Chimney Scan

Over time and use, the metals inside the chimney can break down due to the extreme temperatures and the harsh gasses produced during combustion. As seen in the photos below, the video scan of the inside of this chimney shows signs of deterioration and defective joints. This is an area of serious concern, for the protection of life and property, this fireplace and chimney system should not be used for any type of fire.

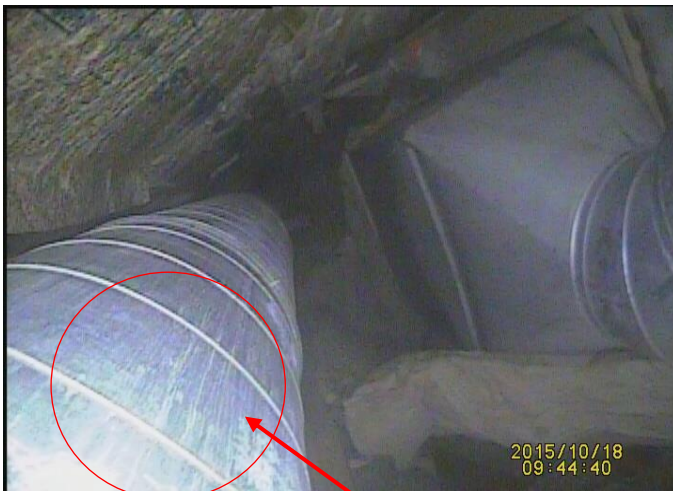
Many of the chimneys in this complex show evidence of moisture on the outside of the outer wall of the chimney. Judging by how the moisture entered and exited the different layers at the joints of the chimneys, it is evident that the moisture has been both on the inside and outside of the outer wall of the chimney. Over time, moisture can break down the integrity of the walls and joints of the chimney, weakening the system and making it unsafe to use. The photos below are representative of the conditions found.

Lines of moisture running in and out of the seams of the outer wall of the chimney

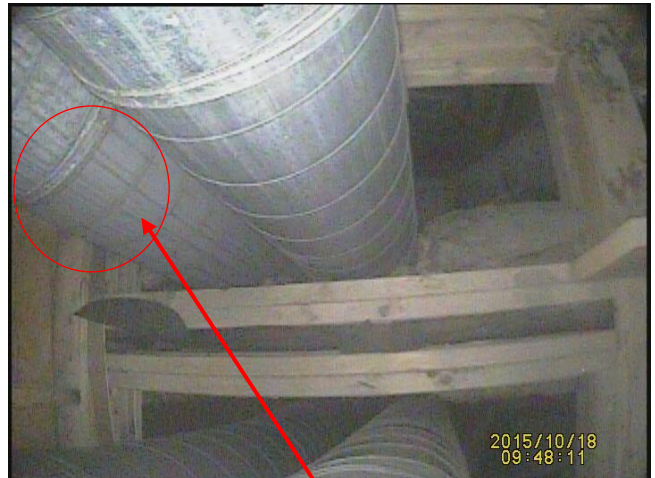
Lines of moisture running in and out of the seams of the outer wall of the chimney

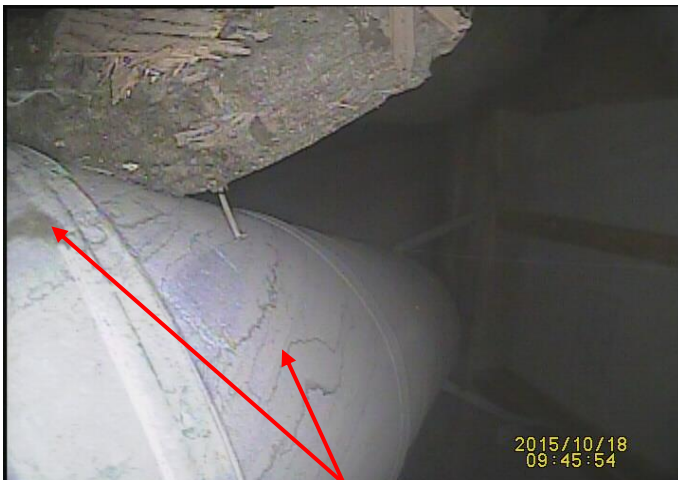
Signs of moisture presents on the outer wall of the chimney

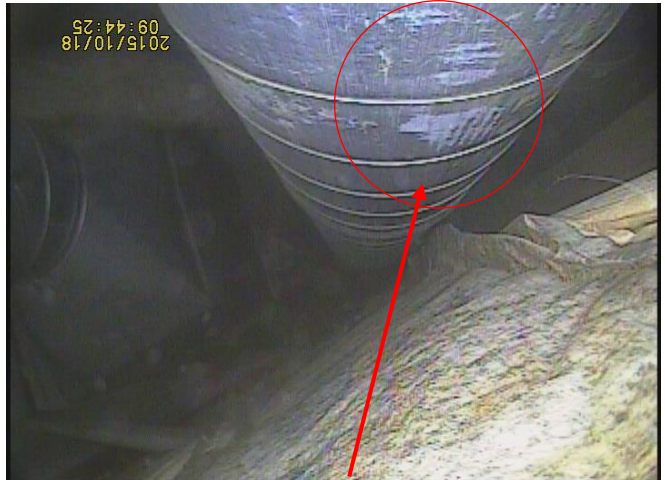
Signs of moisture damage on the outer wall of the chimney

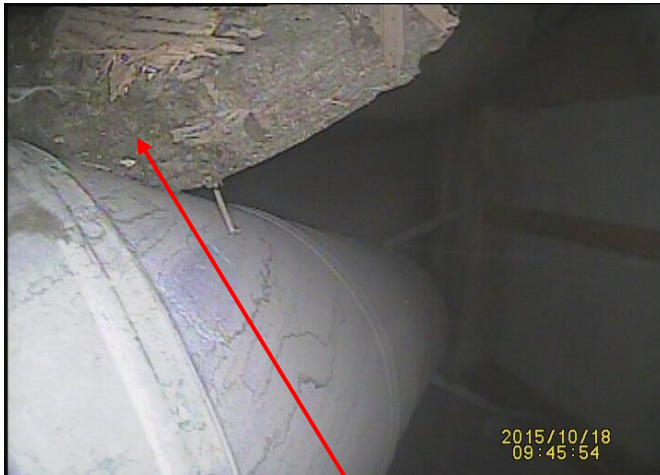
This listed and tested manufactured chimney pipe requires 2" clearance to combustible materials. Inside virtually every chase in the complex, virtually every chimney was in contact with, or had inadequate clearance to, combustible materials. The photos below are representative of the conditions found. This is an area of serious concern, for the protection of life and property, this fireplace and chimney system should not be used for any type of fire.

Combustible building material in direct contact with the chimney. This is a serious fire hazard

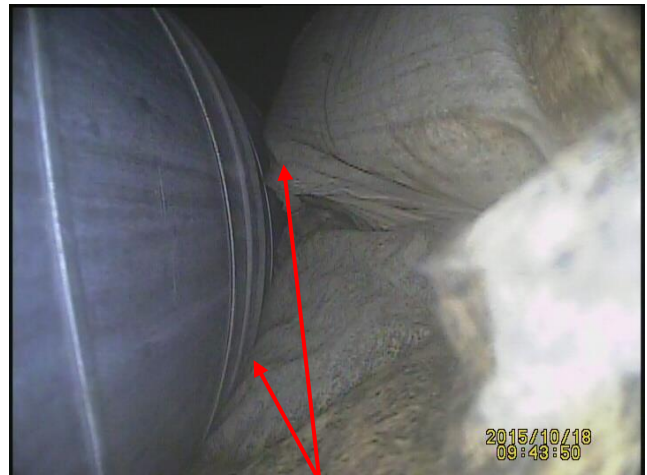
Combustible insulation in direct contact with the chimney. This is a serious fire hazard

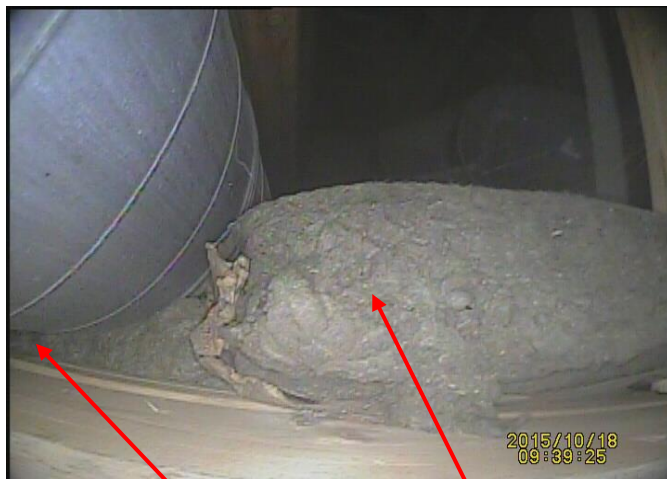
Inadequate clearance to combustible building materials and insulation, which are in direct contact with the chimney. This is a serious fire hazard

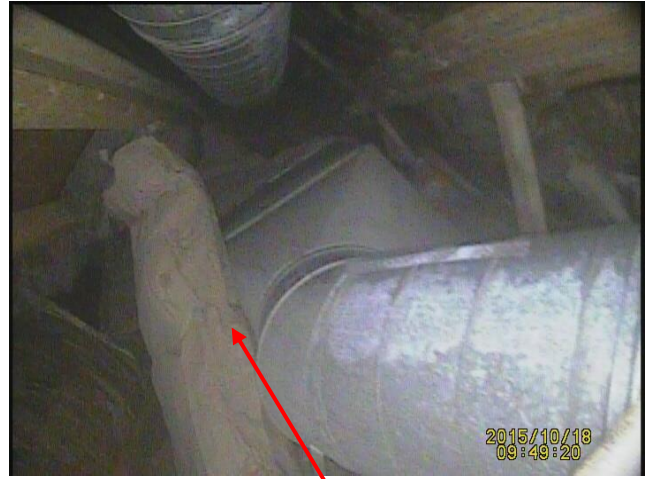
Insulation has fallen on top of a fireplace. This is a serious fire hazard

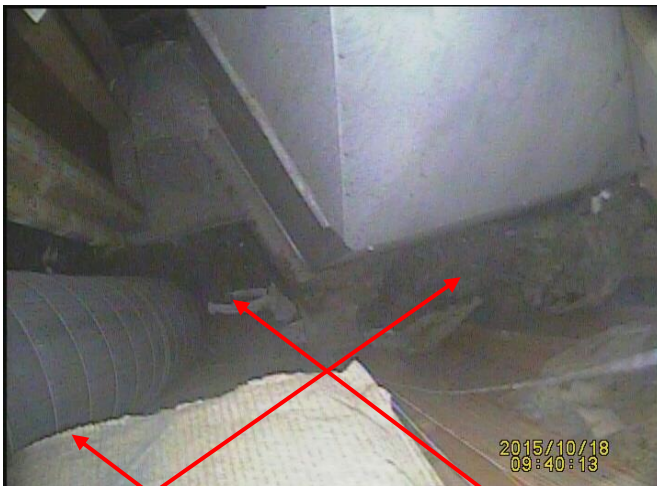
Insulation touching chimney & fireplace, a 2" airspace is required

No firestop provided where chimney passes through floor/ceiling

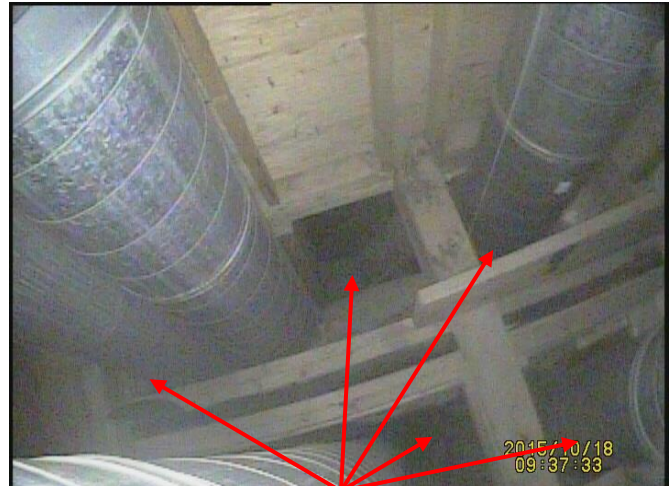
Each chimney must have a firestop where it passes through a floor/ceiling. No firestops have been provided

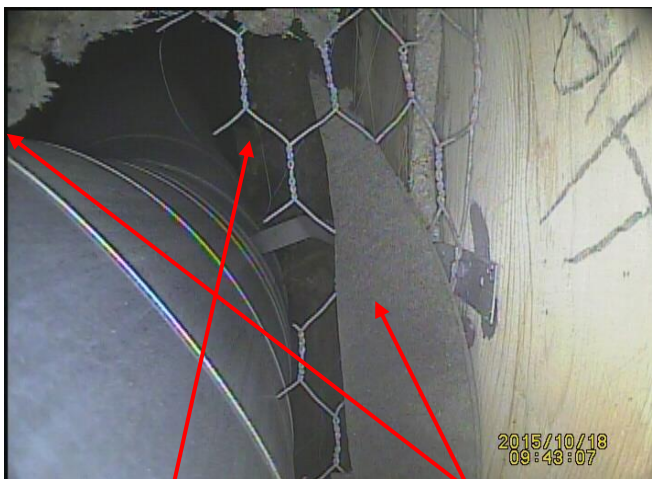
No firestop provided where chimney passes through floor/ceiling

Debris touching chimney, a 2" airspace must be maintained

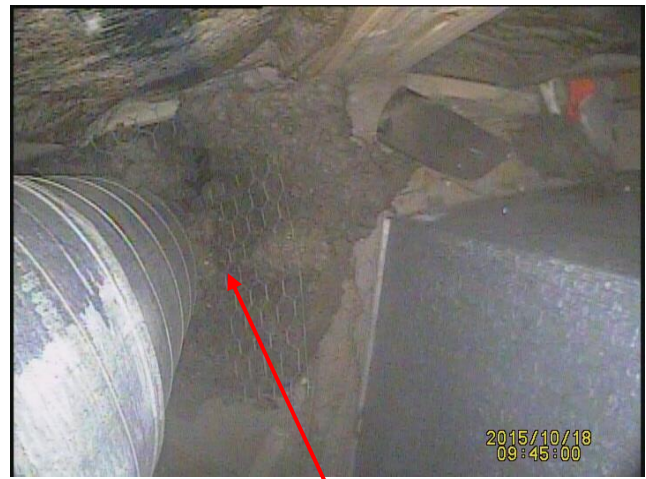
It appears that insulation has been placed on chicken wire in place of an adequate firestop. This is not approved and is a fire hazard
