High Mountain Hearth Solutions, Inc.

18573 G Rd
Delta, CO 81416
Phone (970)596-2342
rick@highmountainheartholutions.com

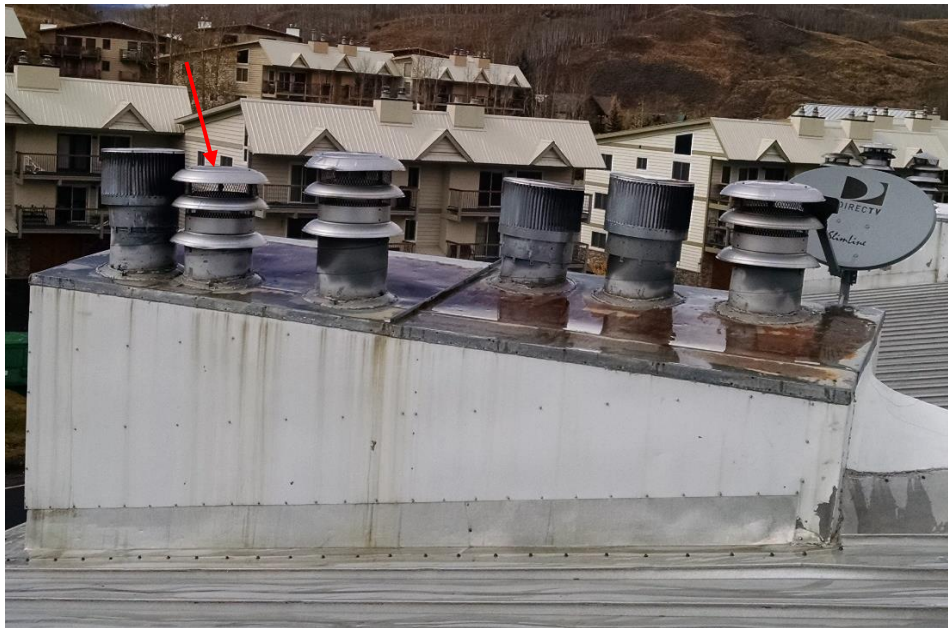
Manufactured Chimney System

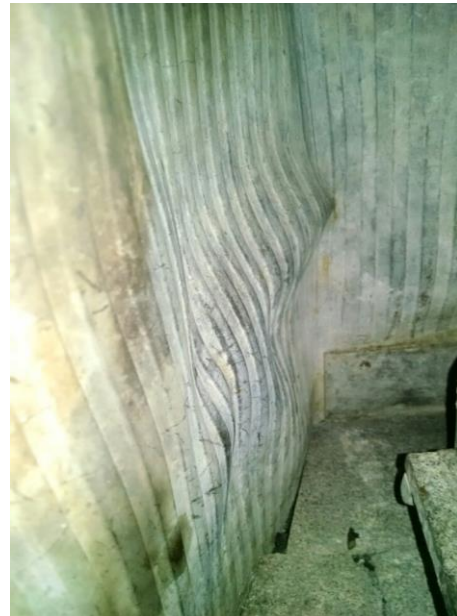
National Fire Protection Association, N. F. P. A. , 211, 2010

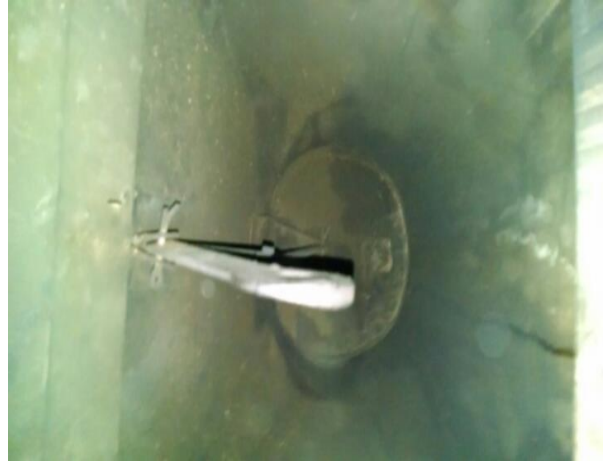
National Fire Protection Association, N. F. P. A., 211, 2010

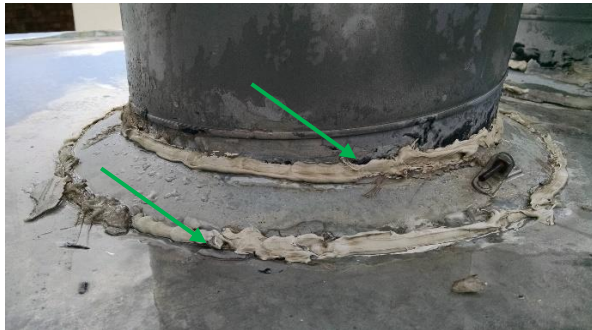
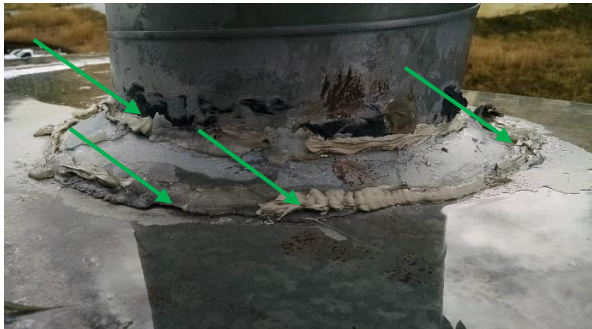
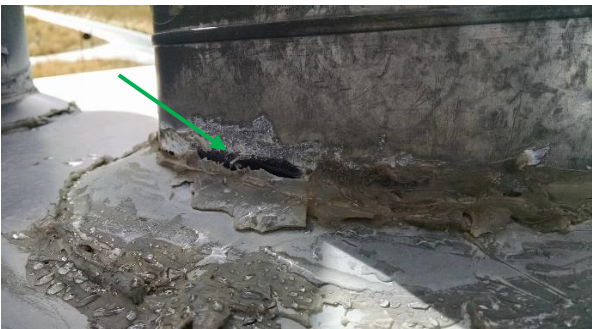
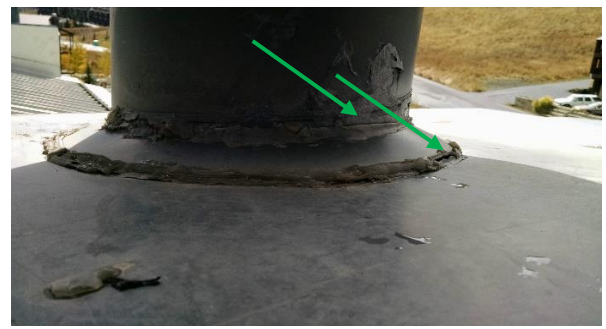
This report has been produced in accordance with our agreement and is subject to the terms and conditions agreed upon therein. All printed comments and the opinions expressed herein are those of the Inspection Company.

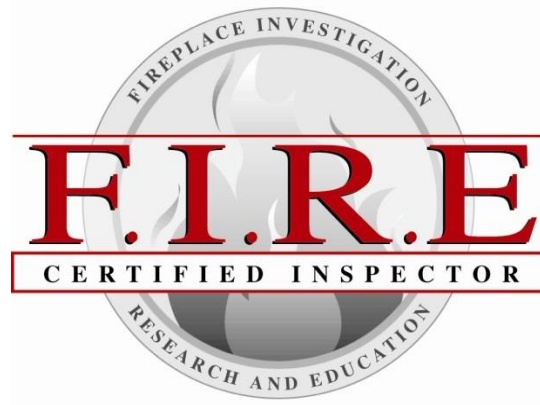
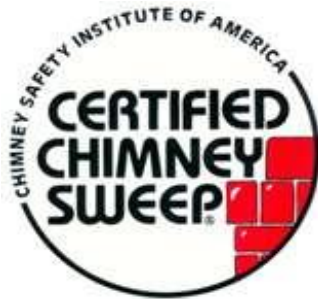
This report has been produced in accordance with our agreement and is subject to the terms and conditions agreed upon therein. All printed comments and the opinions expressed herein are those of the Inspection Company.
