Confidential Inspection Report

Three Seasons Condominiums

701 Gothic Rd
Mt Crested Butte, CO 81225

N.F.P.A. Level II Chimney Inspection

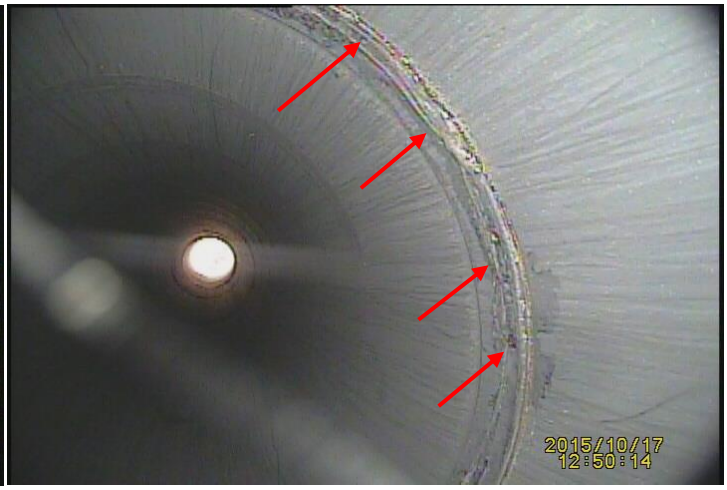
Interior Chimney Scan

Over time and use, the metals inside the chimney can break down due to the extreme temperatures and the harsh gasses produced during combustion. As seen in the photos below, the video scan of the inside of this chimney shows signs of deterioration. This is an area of serious concern, for the protection of life and property, this fireplace and chimney system should not be used for any type of fire.

A.14.3 (Chimney inspection required to ensure).....(5) Chimney or vent and its connector for general suitability....

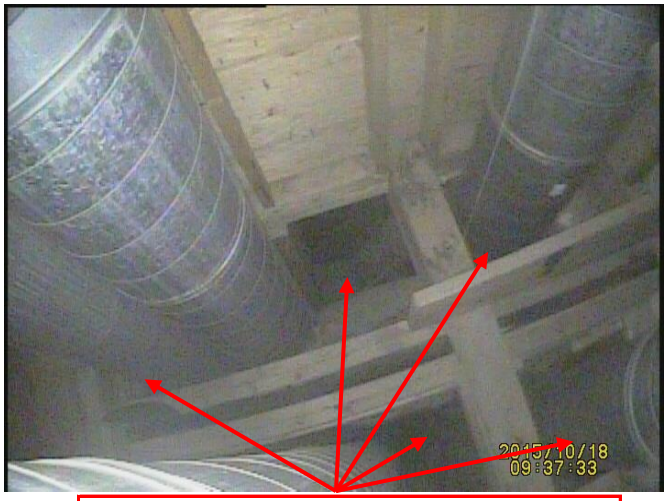
Each time a chimney passes through a floor or ceiling a firestop is required to prevent or slow the spread of flames and smoke in the unfortunate event of a fire. Units on the first floor should have 3 firestops, one at the first floor ceiling, second floor ceiling, and third floor ceiling. Second floor units should have two firestops, and third floor units should have one. Throughout the entire complex we found virtually no adequate firestops. The photos below are representative of the conditions found. This is an area of real concern, for the protection of life and property, this fireplace and chimney system should not be used for any type of fire.

7.1.6.2 All spaces between chimneys and the floors and ceilings through which the chimneys pass shall remain fully open but shall be firestopped with noncombustible material.

No firestop provided where chimney passes through floor/ceiling

Each chimney must have a firestop where it passes through a floor/ceiling. No firestops have been provided

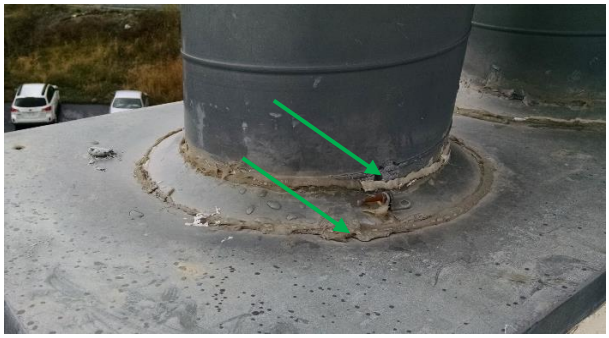
The photos below show that the metal composing the chase covers on this complex is rusting and deteriorating. At the time of this inspection the covers have not rusted through, but it is recommended that these chase covers be replaced in the near future to prevent property damage. The photos below are representative of the conditions found.
